Professional Home Inspections

CONFIDENTIAL INSPECTION REPORT

1234 Ocean, San Diego, CA 92105

Structure Style: 20 Unit Apartment Bldg

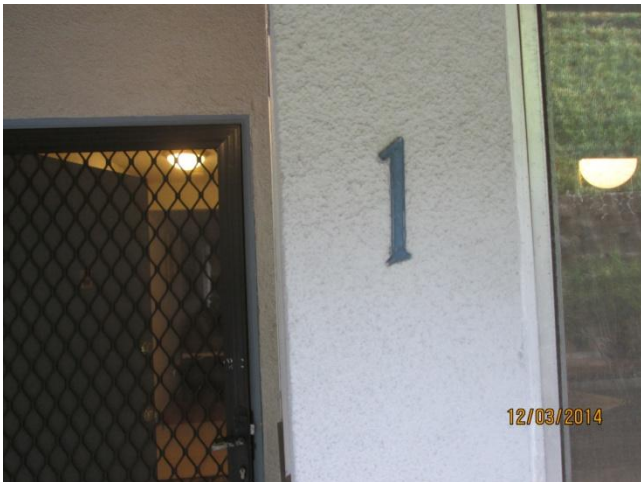
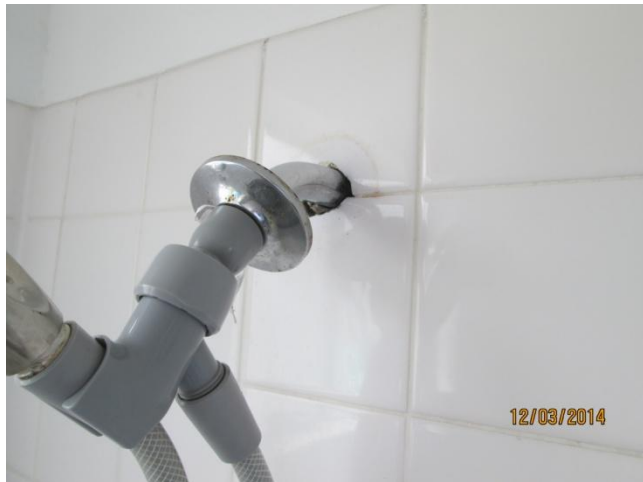
Cracked tiles, lacking caulk seal at fixtures.

Visible water damage, blistering and wet ceiling in unit 2 bathroom.

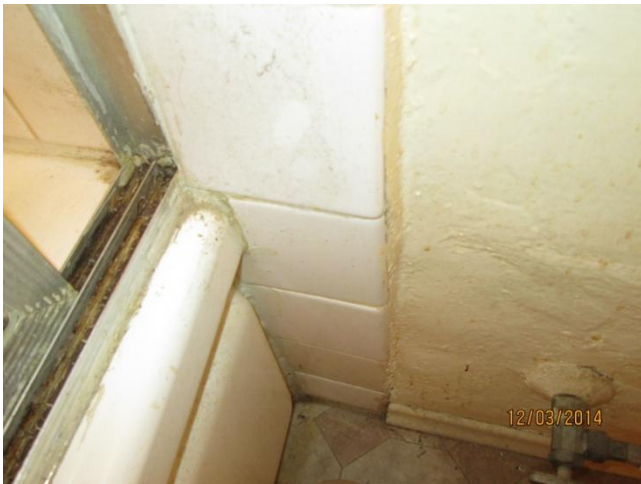
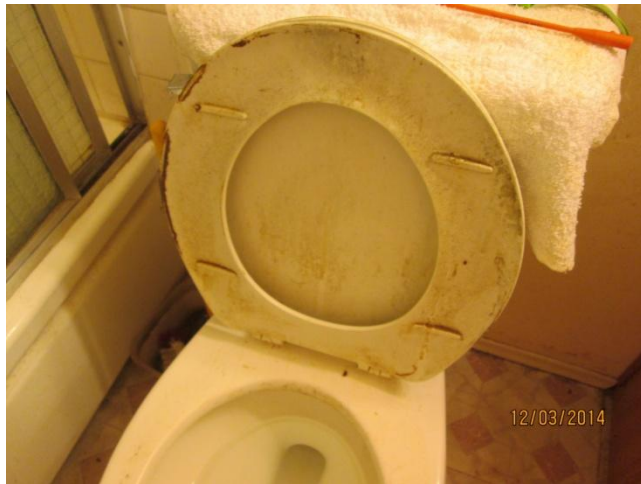
Elevated moisture levels on drywall next to tub and around angle stop evidence of patched wall repair work. Surface mold growth in bathroom especially on toilet seat and fixture. High humidity in bathroom and unit.

Toilet not seated properly. Bathroom sink cabinet has past water damage, needs replacement.

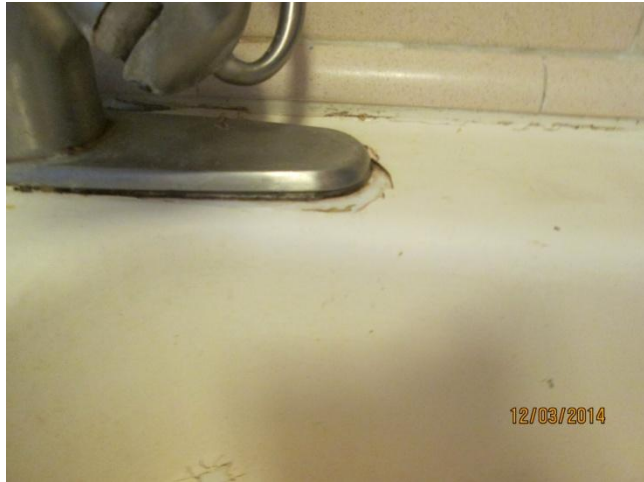
Kitchen sink refinishing is delaminating as seen at fixture bottom edge.

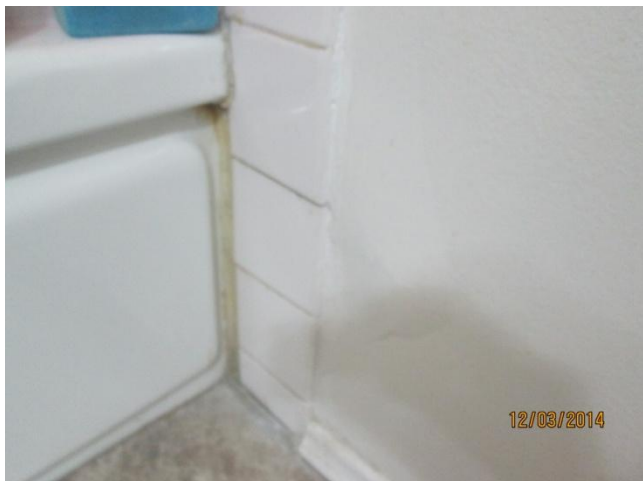
Bathroom shower enclosure tile has cracks; some tile in field is buckling, moisture levels could not be measured as tiles were wet.

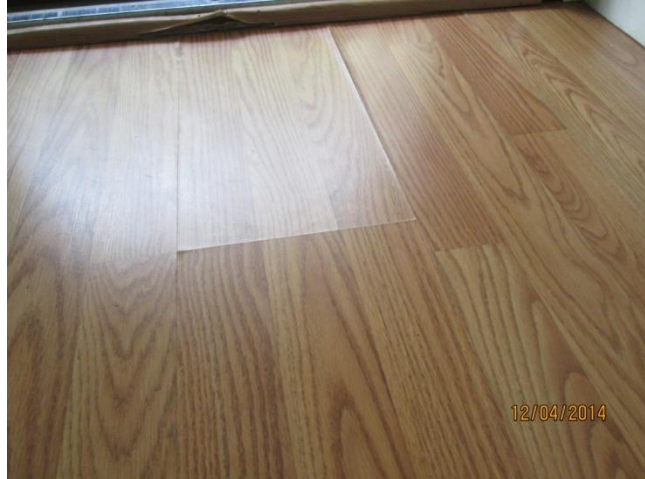
Entry laminate flooring is wet going into hallway area may be related to water entering under threshold to front door.

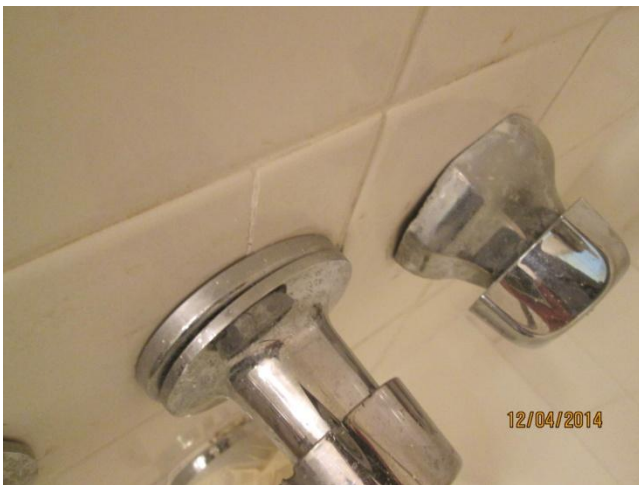
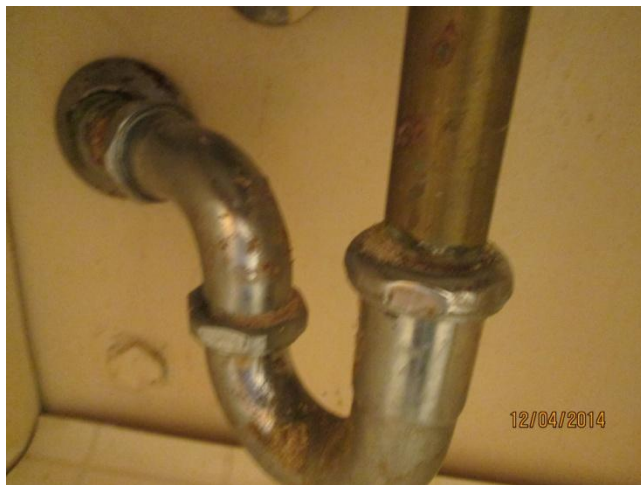
Bathroom wall has elevated moisture levels next to angle stop valve. Tub enclosure tiles have numerous cracks in the field. Fixtures need caulk sealing.

Fixtures need caulk sealing to tile, sink plumbing is aged and will need replacement.

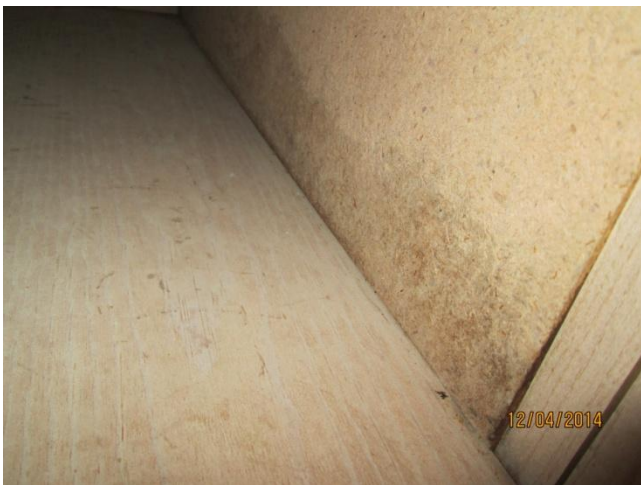
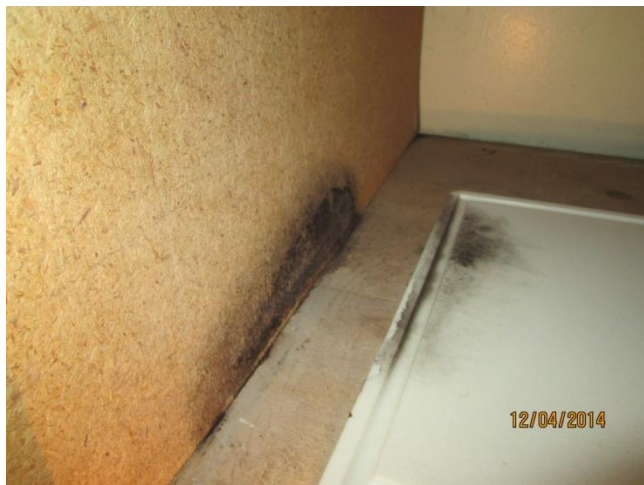
Kitchen sink in poor condition. Sink cabinet has water damage and visible mold.

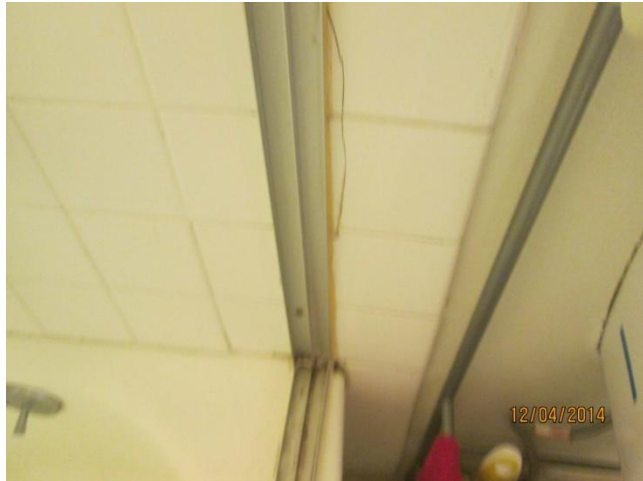
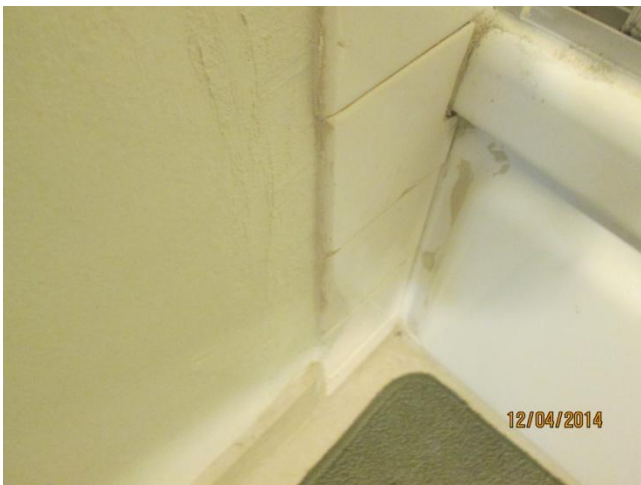
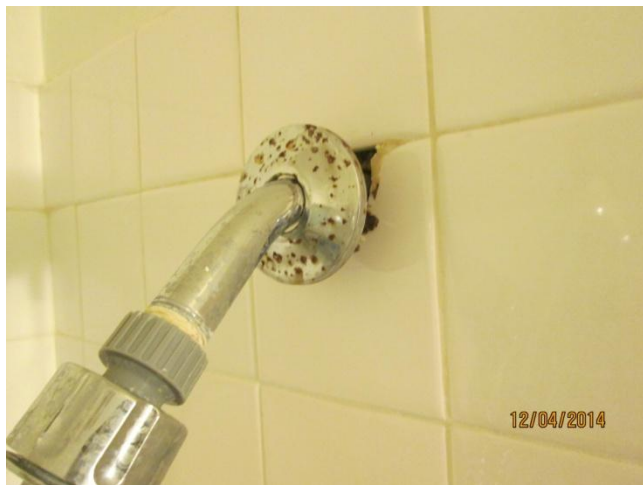
Shower tile was wet, elevated moisture readings behind tiles, enclosure tile is buckled in areas, tile in field is cracked and all fixtures lacking caulk sealing to tile.

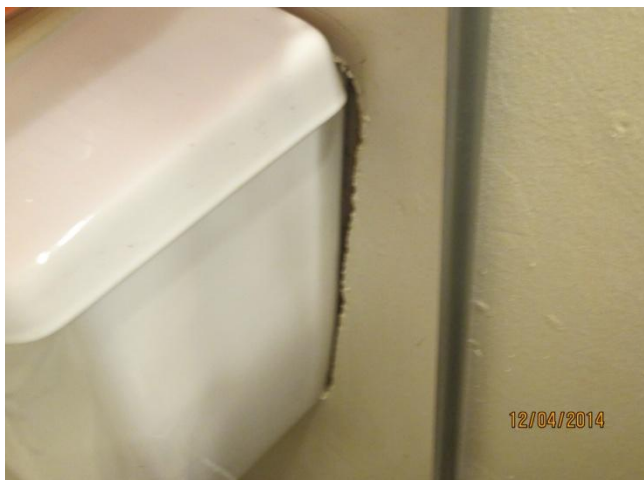
Drywall cut in bathroom to accommodate oversized toilet. Kitchen sink rear seal not sealed properly, no active water leak found. Past water damage noted to kitchen cabinet.

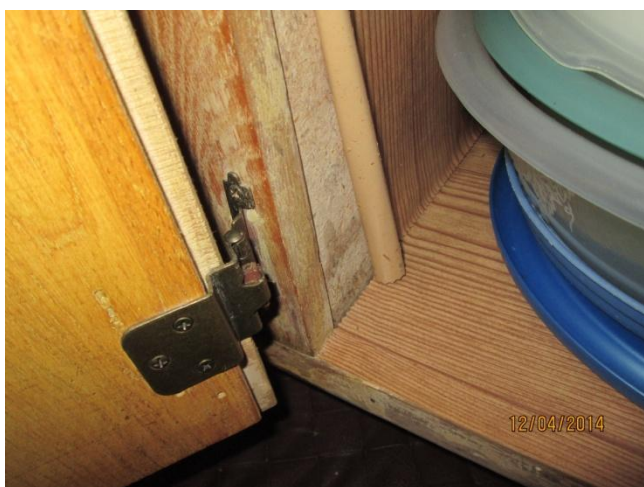
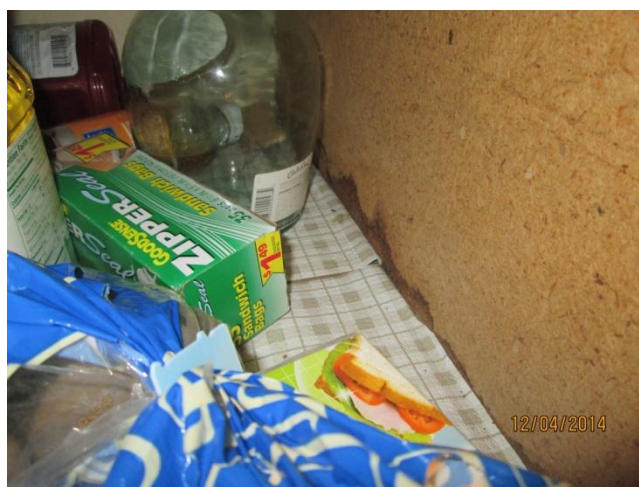
Past water damage noted to kitchen sink cabinet and base.

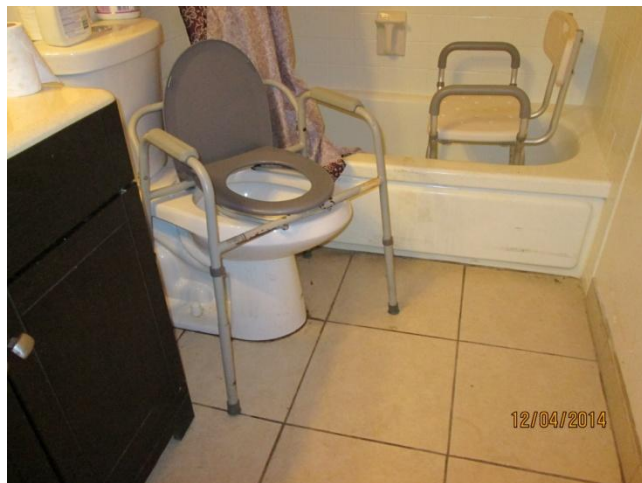
Unit 7 is a handicap unit. There is damage to walls and trim associated with wheel chair use. The bedroom has pet issues, feces noted on carpet surface. Tub fixtures need caulk sealing.

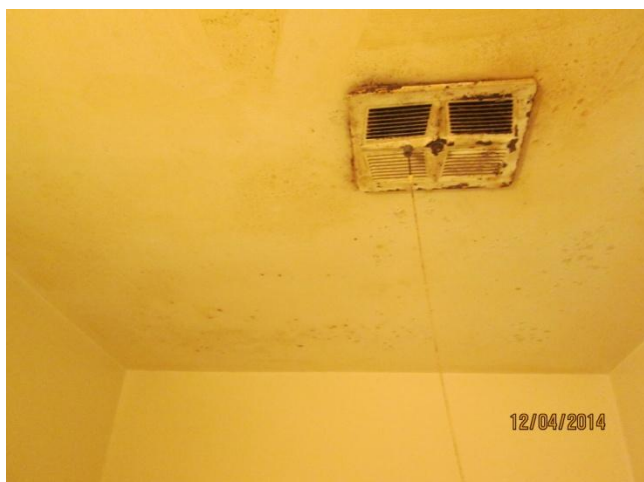
Bathroom ceilings and walls are cigarette smoke stained along with water spots from shower moisture etc. Wall surface does have visible mold.

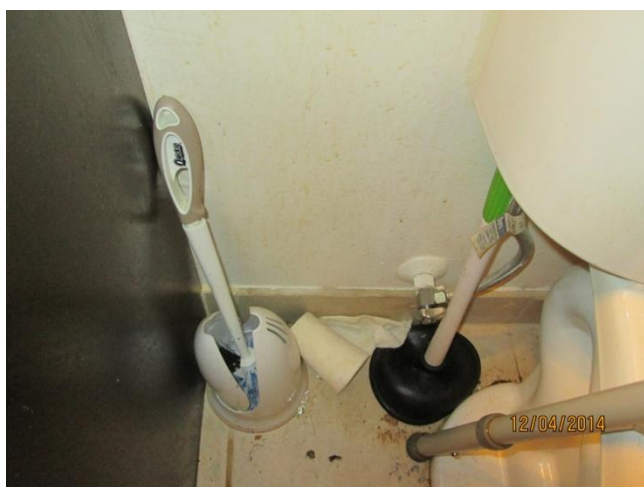
Wall behind toilet and sink cabinet has elevated moisture levels, the cabinet is wet and has visible mold.

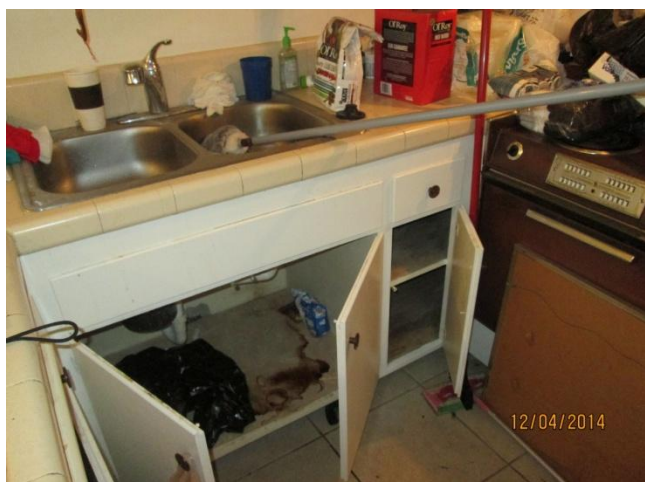
Kitchen cabinets, counter tops are original construction, have past water damage, visible mold and will need replacement.

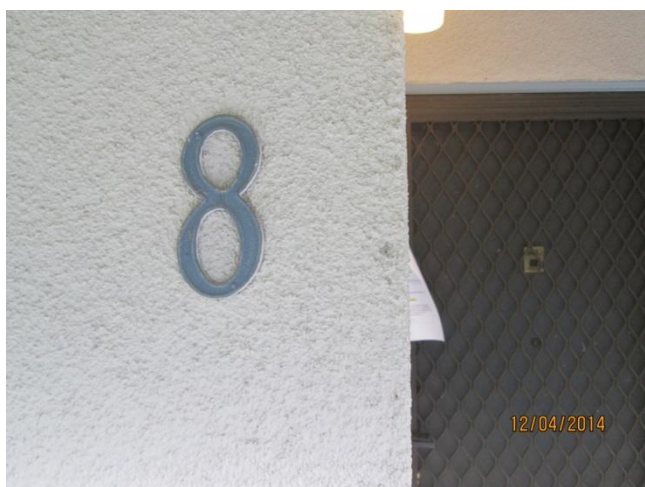
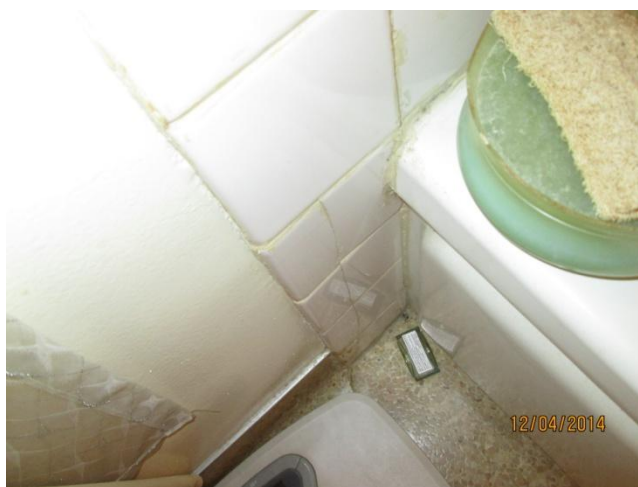
Bathroom tub enclosure tiles are cracked and fixtures need caulk sealer. No elevated moisture levels found on tile field. Ceiling has evidence of past repair and patch work.

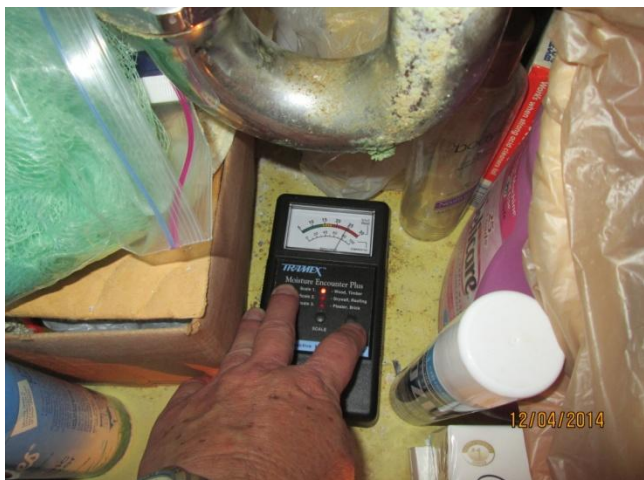
Under sink in bathroom elevated moisture levels and poor drain pipe condition appears to be leaking.

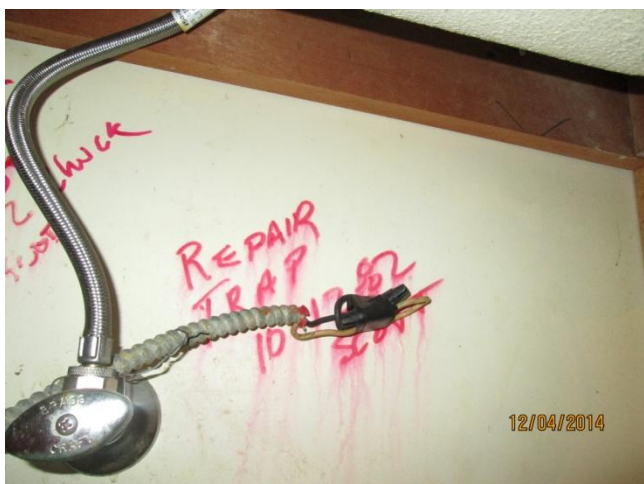
Under kitchen sink revealed dangerous wire situation. Former water damage stains remain in cabinet side panels and bottom shelf. These are dry now.

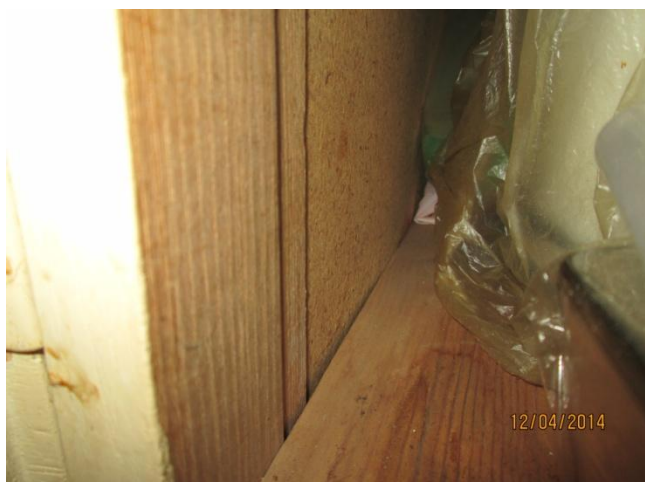
Opposite side of previous photo cabinet panel showing no damage. Kitchen is original construction and will need replacement soon.

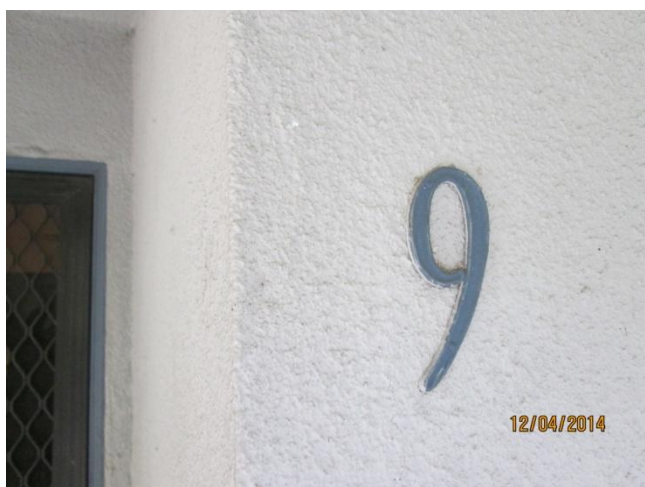
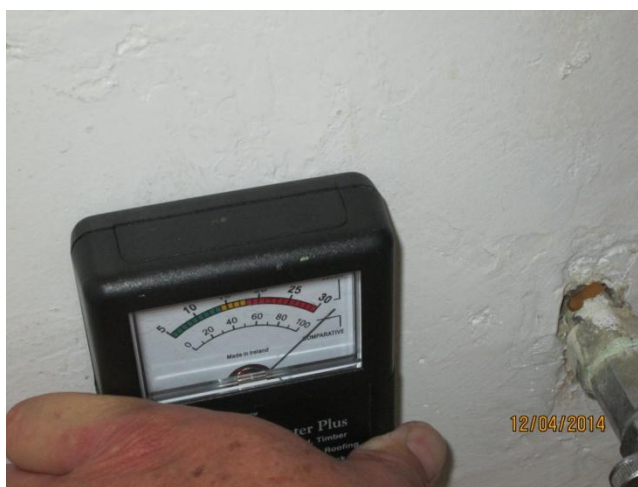
Bathroom wall at angle stop valve has elevated moisture levels.

Sink cabinet in bathroom has wet shelf and side panels. Particle board is damaged.

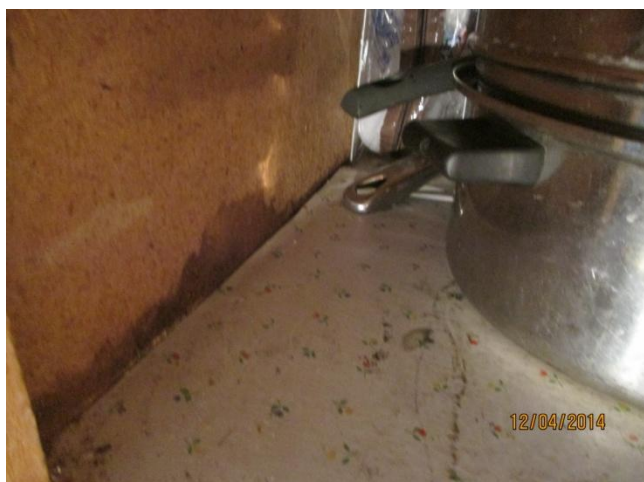
Kitchen sink and cabinet have leak issues and past water damage. Mold noted at cabinet interiors. Cabinets are not original construction but appear to be 25 years plus old, and may need replacement soon.

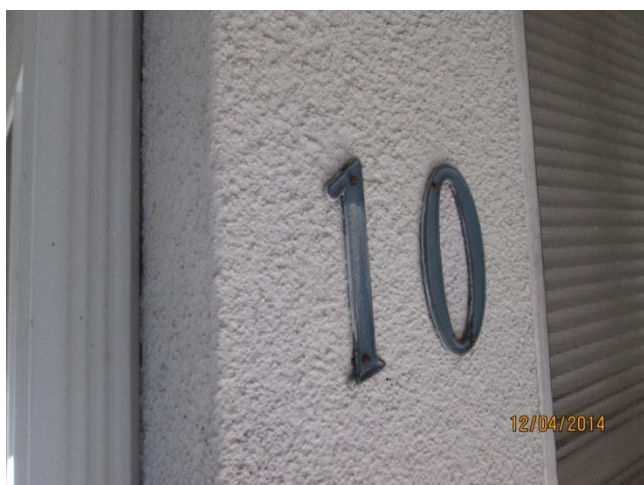
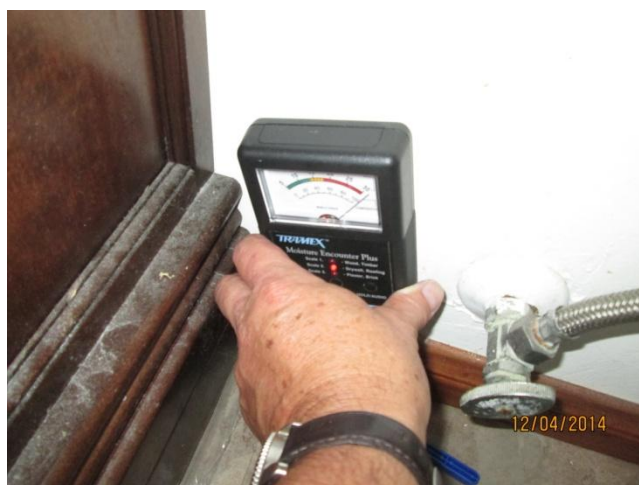
Elevated moisture levels found around toilet angle stop valve on walls. Water runs off cabinet counter top above to this side of the wall.

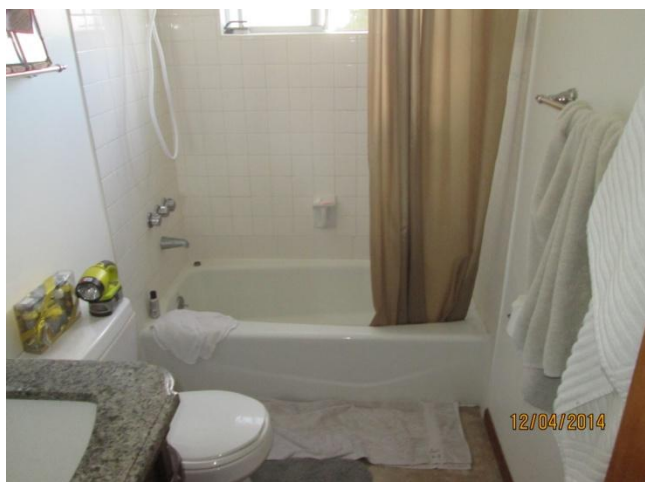
Tub enclosure fixtures need caulk seal. No moisture meter measurements taken on tile surround due to recent shower activity. Wall between toilet and tub tile is showing elevated moisture levels.

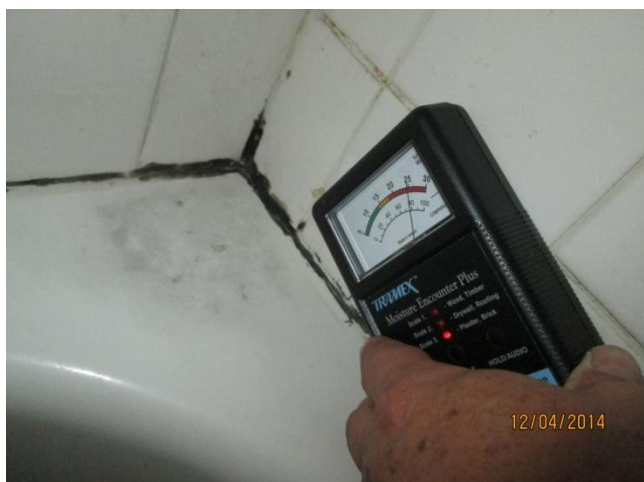
Elevated moisture levels found in wall next to shower wall and between angle stop valve. Shower tile plumbing wall shows elevated moisture levels behind tile. May be the cause of wet wall next to shower and toilet. Bath sink faucet is not sealed properly to cabinet counter. No elevated moisture levels found with the cabinet.

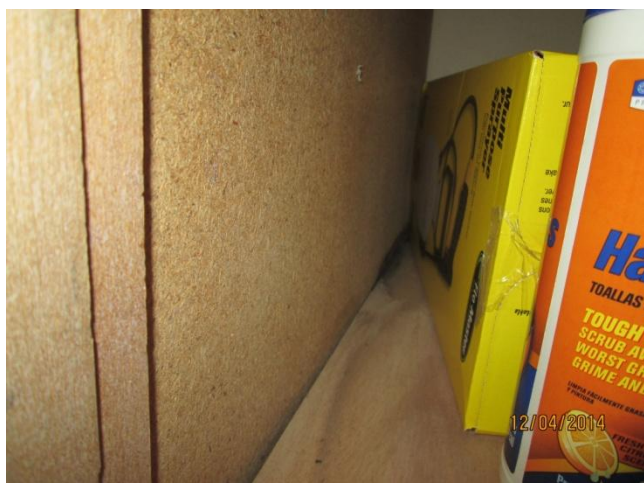
Kitchen water damage and visible mold found in cabinet to right of sink cabinet. Sink cabinet above right shows it has been painted and the particle board side panel shown is swollen from previous water damage event.

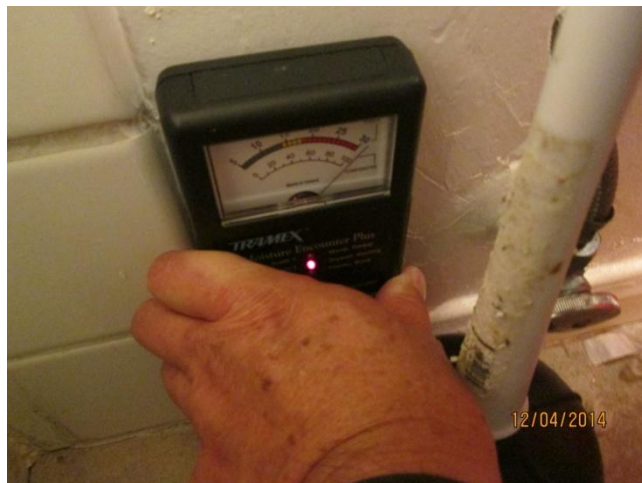
Tub enclosure plumbing wall behind tile is showing elevated moisture levels as well as tile to side of tub and drywall next to tub towards and behind toilet. Toilet runs continuously.

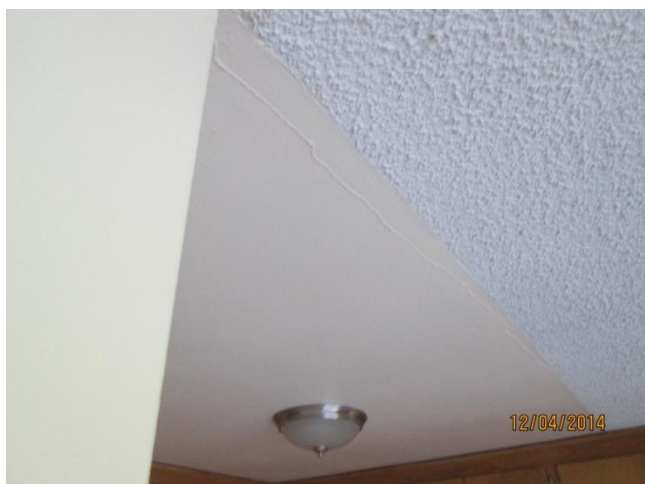
Kitchen ceiling has repaired crack in the same direction as living room crack. The sink cabinet has past water damage and the damaged cabinet side wall panel has been painted.

Backside of panel showing unpainted water damage in side cabinet in kitchen. The warped water damaged base molding on kitchen cabinet is shown above right.

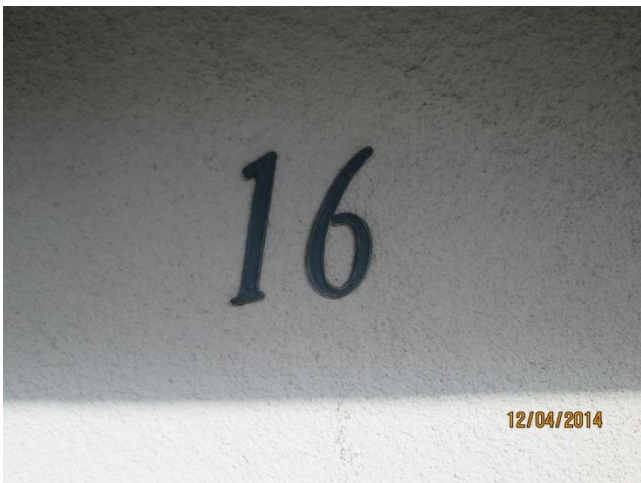
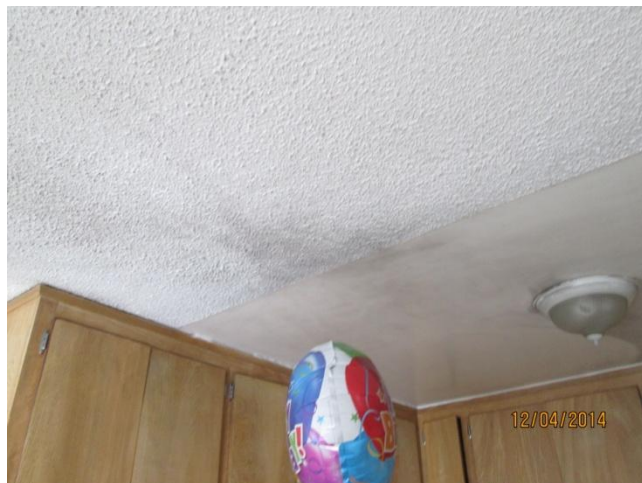
Kitchen ceilings and cabinet exteiors affected by smoke damage from previous fire event.

Additional view of other area of smoke damage in kitchen. No other issues noted in this unit.

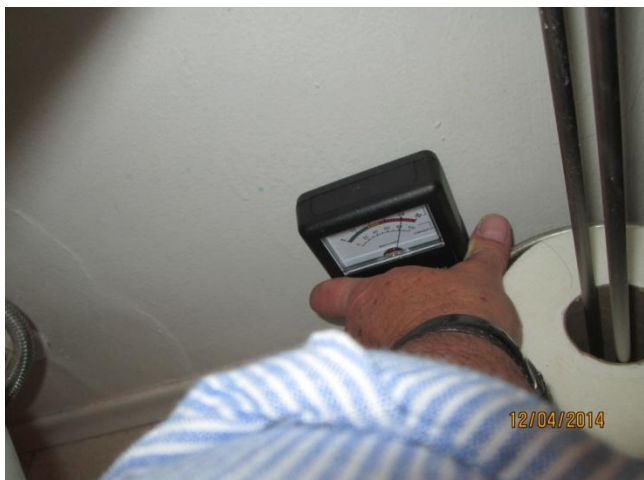
Elevated moisture levels found to right of tub on wall behind toilet. Living room ceiling has a repaired crack running the width of the room.

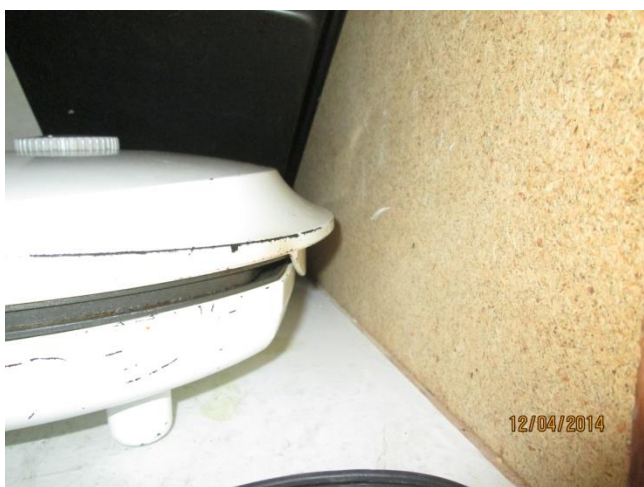
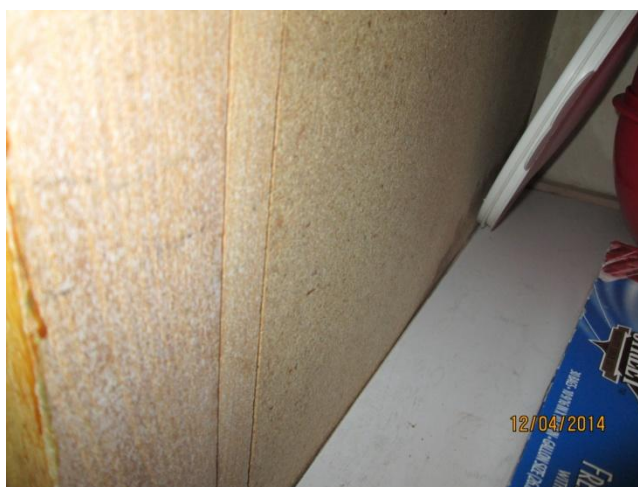
Kitchen sink cabinet right side panel has past water damage to back part of panel near shelf.

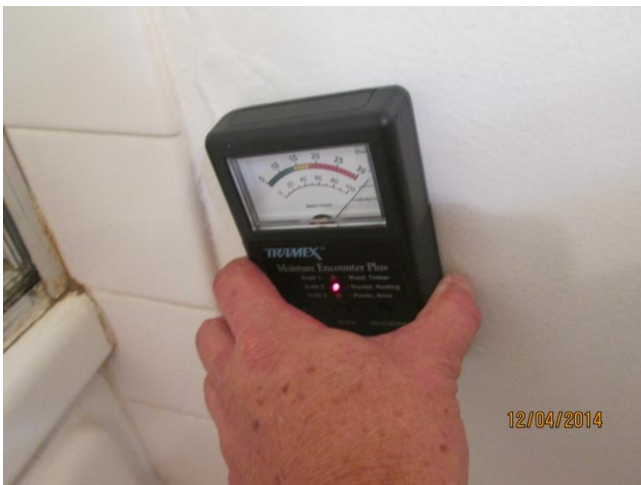
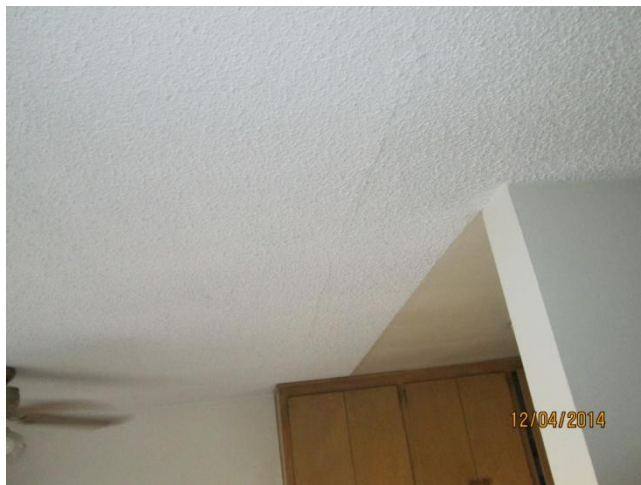
Elevated moisture levels going up 2' from floor to side of tub enclosure in bathroom. Dining room ceiling has repaired crack running the width of the ceiling.

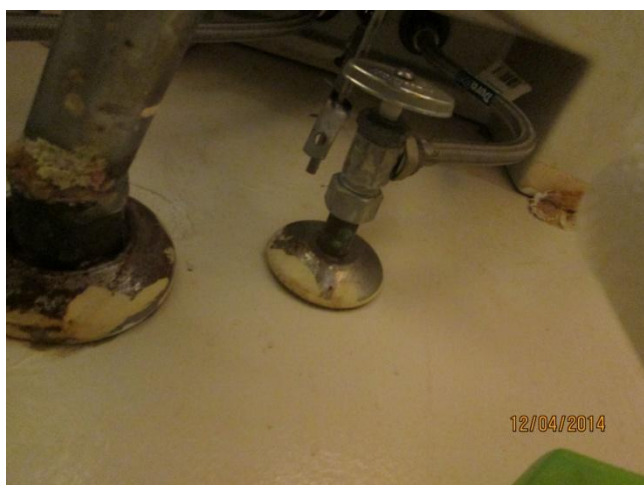
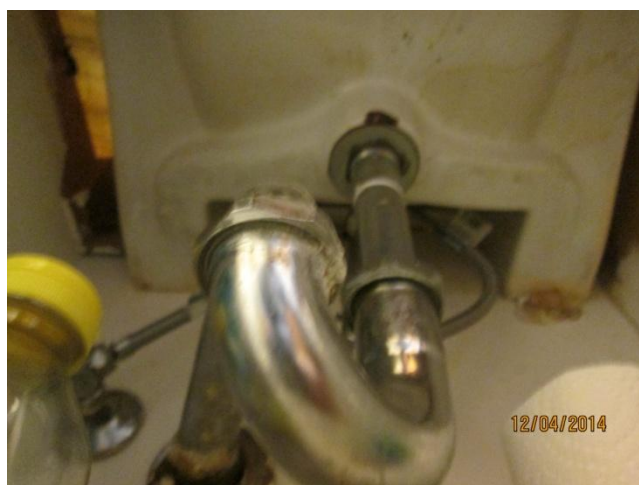
Bathroom sink plumbing in poor condition. No leaks presently but needs to be replaced.

Kitchen sink in poor condition needs replacement.

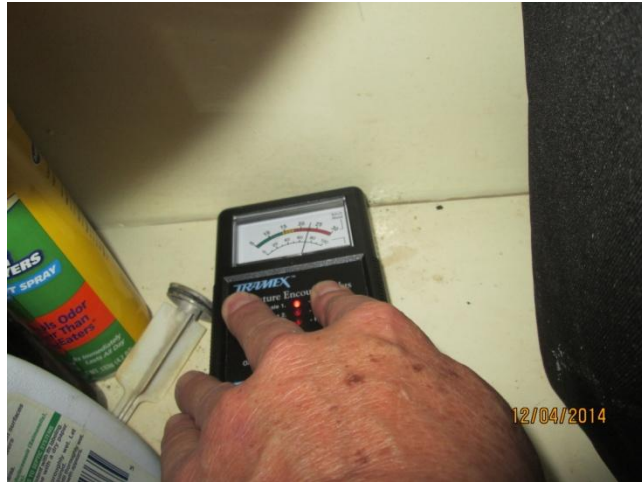
Bathroom sink cabinet shelf has elevated moisture levels due to lack of good caulk seal at rear of sink.

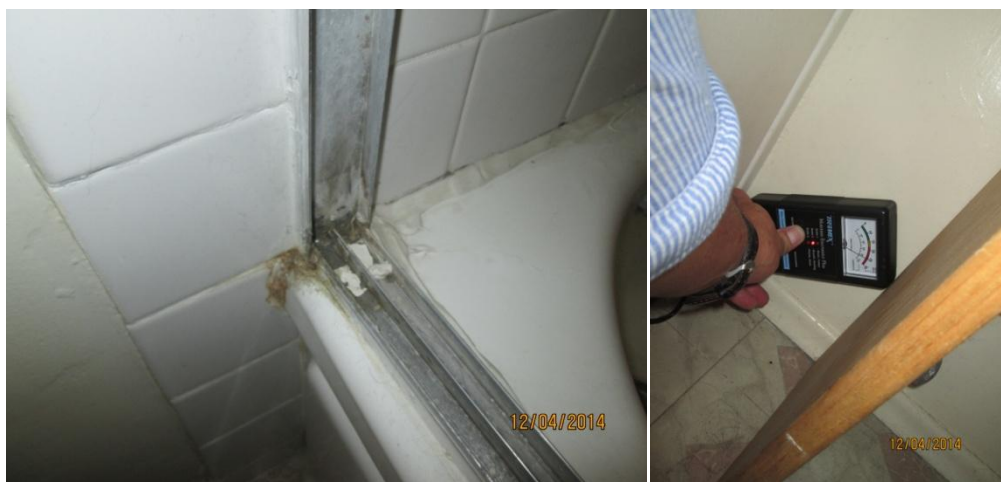
Tub to shower door seams appear to leak. Wall next to tub and behind toilet reads elevated moisture levels.

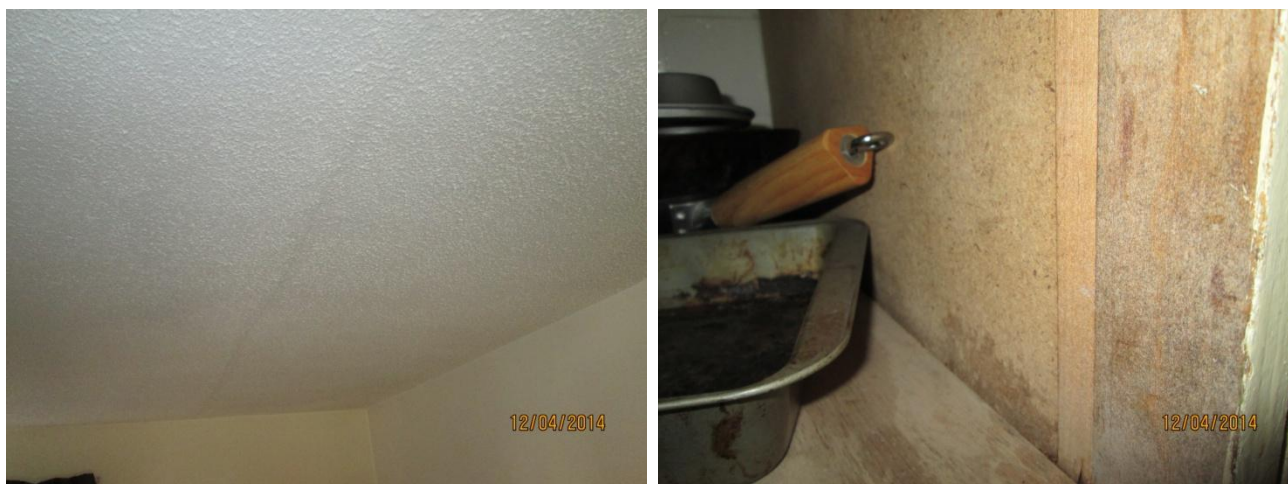
Living room ceiling has repaired crack running length of the room. Kitchen sink cabinet has past water damage to interior. No elevated moisture levels present.

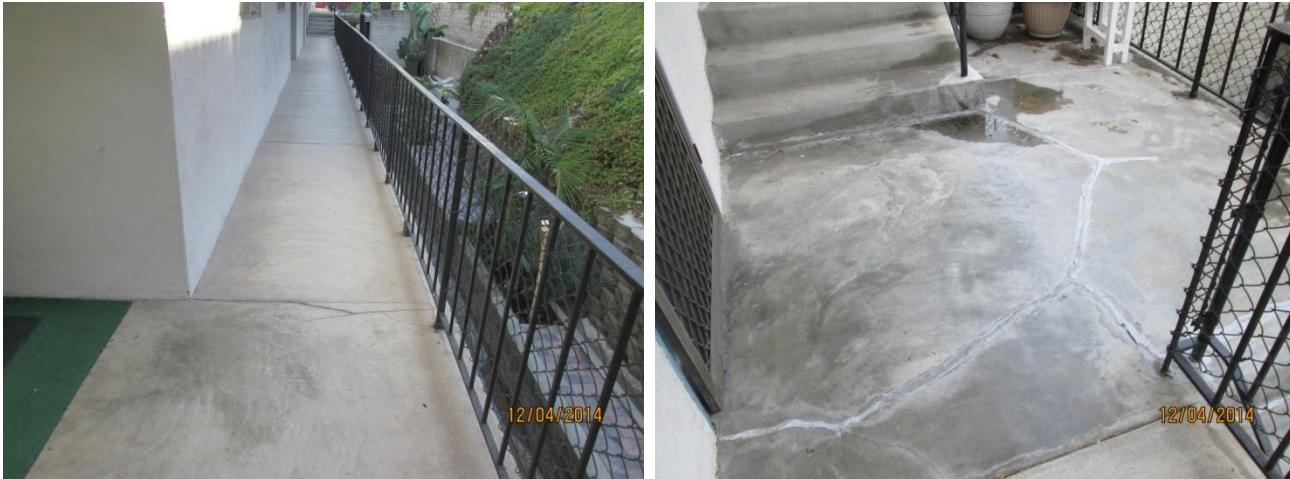
Upstairs balcony walkway with surface cracks that allow water into structure and is damaging the soffit area below.

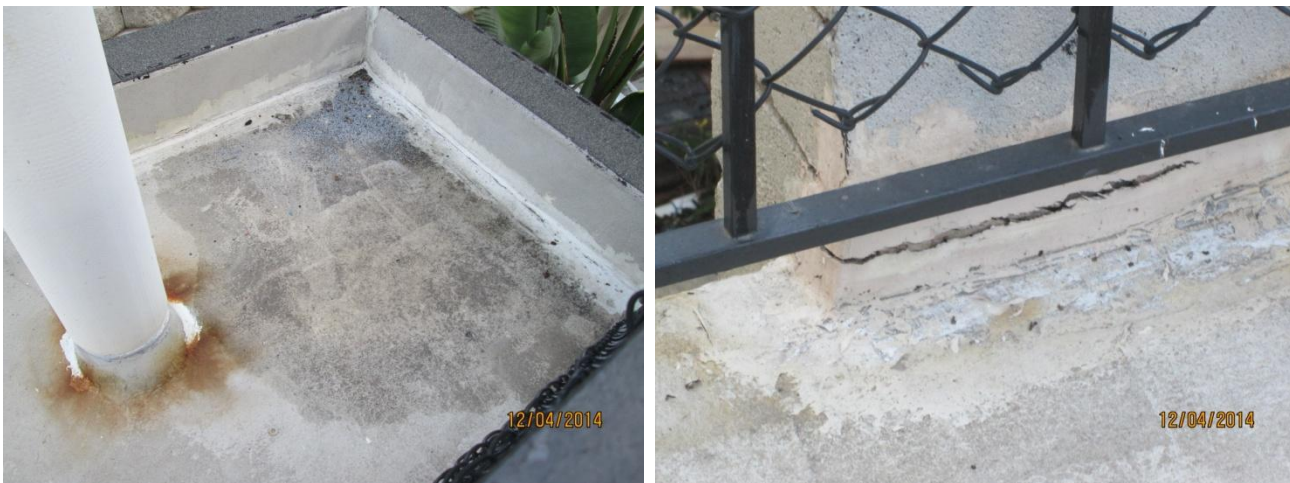
Compromised water proofing above laundry room and water heater room.

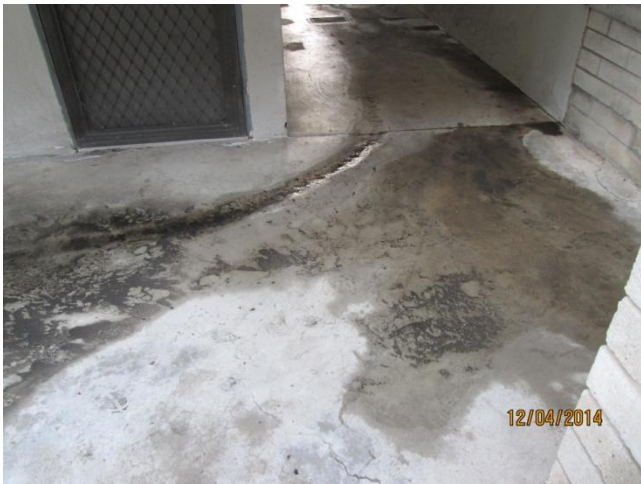
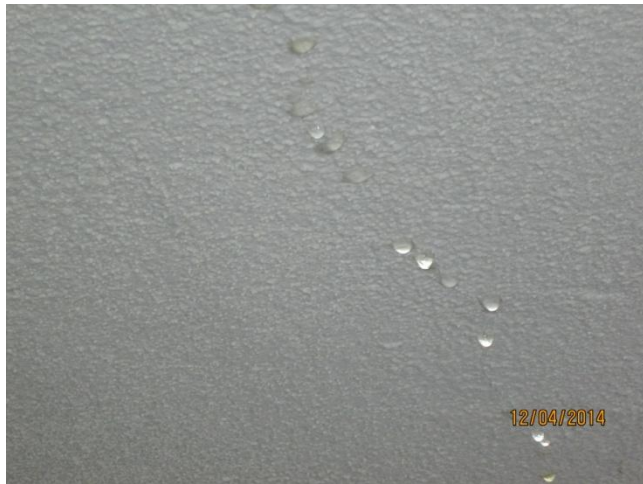
Results of water entering cracks on second story balcony walkway and dripping through the soffit area, stucco to the sidewalk in the main traffic area below.

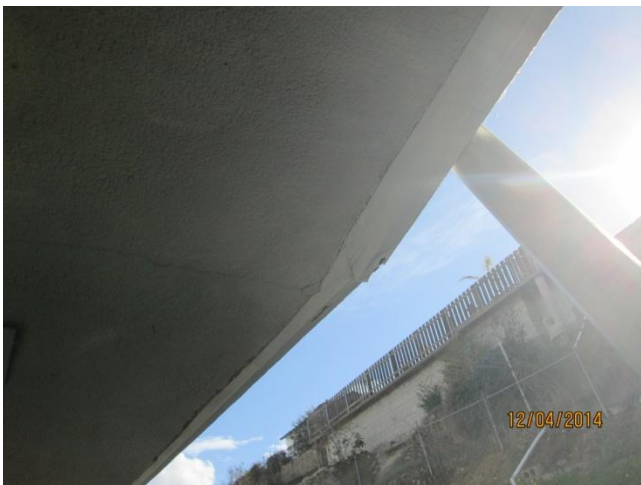
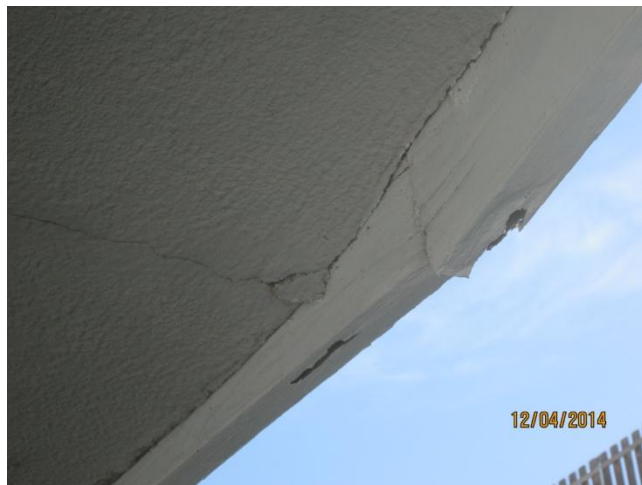
Roof above second story walk way showing eave and fascia water damage and rot.

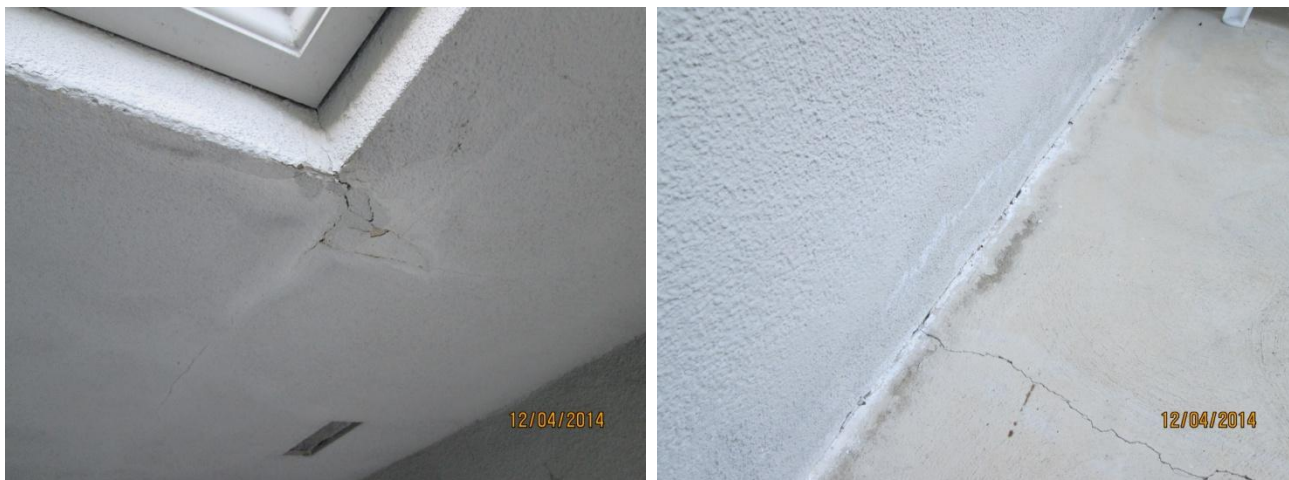
Additional damage from water entering balcony walk way surface and draining through stucco below. Unknown damage occurring inside framed soffit area. Photo above right shows base of stucco wall where it has been repaired in spall location due to moisture wicking up the stucco.

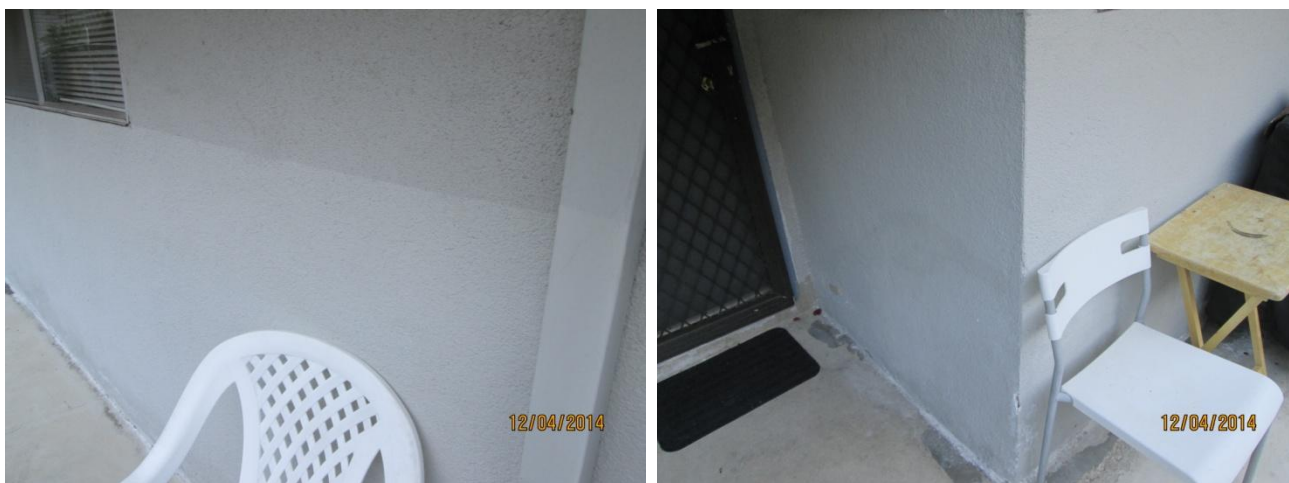
Wall has been painted from below window down. The stucco has been patched along the bottom two feet due to blistering and spall from moisture.

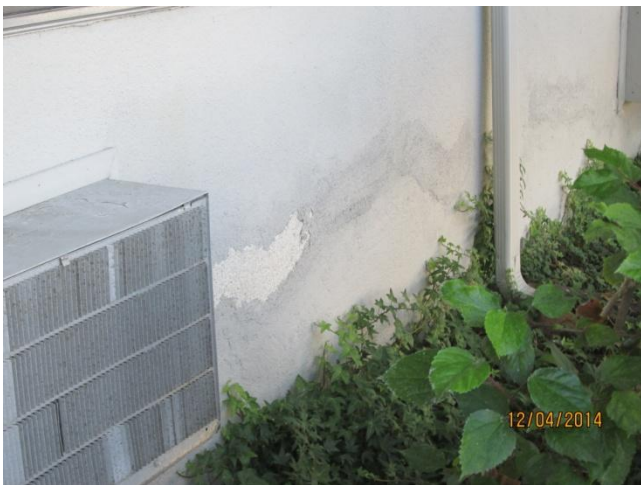
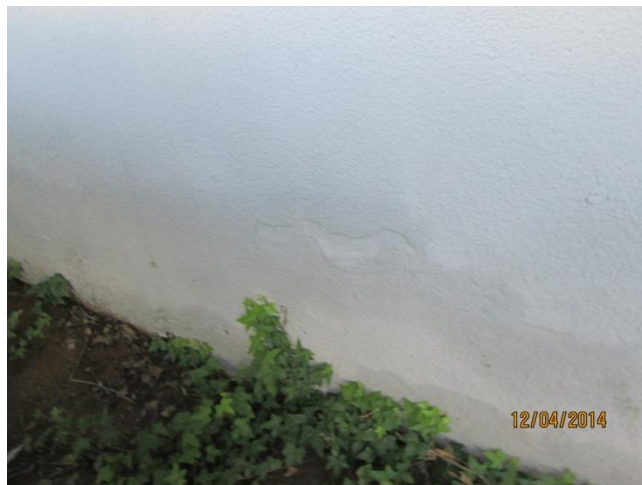
The stucco extends down to the soil or ground without the benefit of a weep-screed. Weep screed is a horizontal strip of metal that isolates the stuccoed house walls from the foundation and allows them to move independent of the foundation. This not only prevents horizontal cosmetic cracks that are commonly seen at the base of many stuccoed walls but also isolates the stucco from the soil and inhibits the wicking effect of moisture being drawn up into the stucco which in turn creates the flaking and peeling that is common on such surfaces.

Above photos show stucco damage, spall and blistering from excess ground moisture wicking into the stucco material due to lack of weep screed installed at the stucco wall.

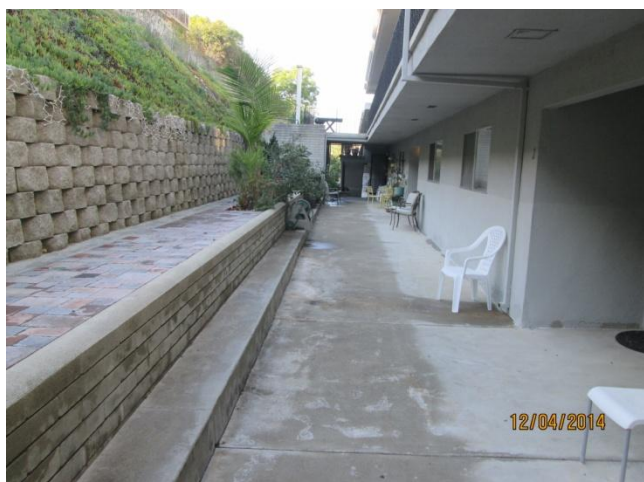
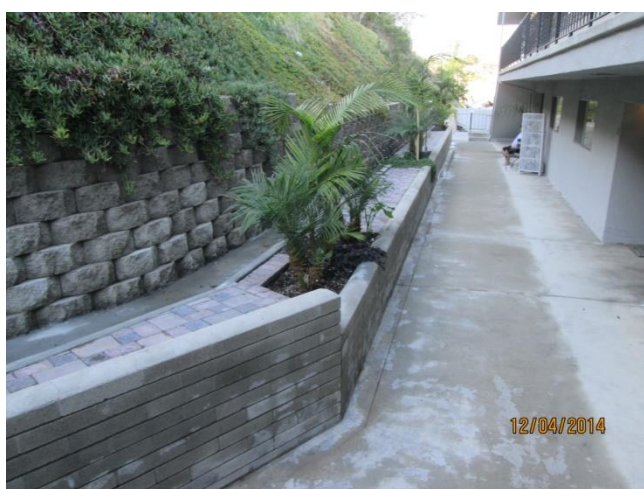
Above photos show the complex rear elevation retainer wall system and drainage that appear to have been subject to designed by engineer and implemented to stabilize hillside and provide water release from the slope. Consider retaining the appropriate engineer to evaluate wall system and hillside stability as well as effects on foundation and the structure in general.
