ACCREDITED INSPECTION

Red Flags Report Pre-Listing

Address of Property: 1234 Menlo Ave., San Diego, CA 92115

TYPE OF PROPERTY: 14 unit apartment complex

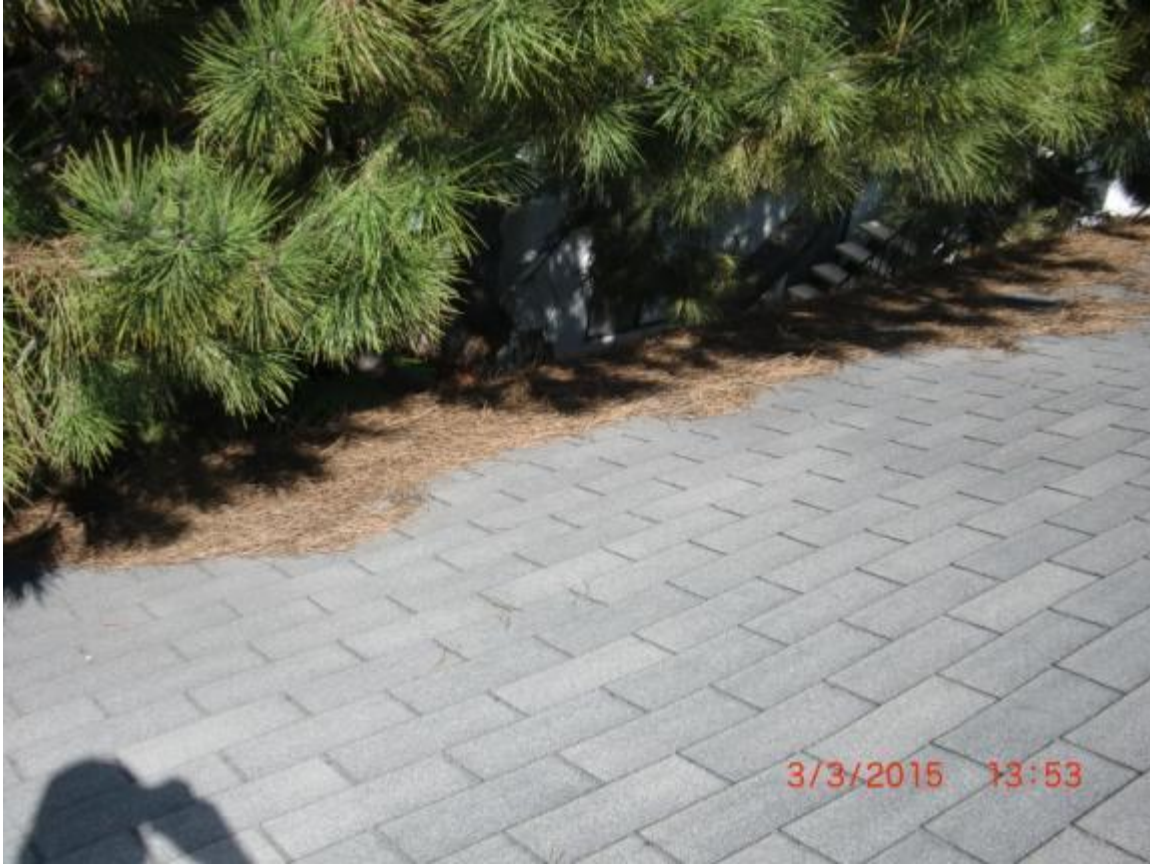
3. The biggest concern on the exterior is the neighbor's pine tree which reaches over this property dropping debris on to the roof and the gutters. It does not look like it has had an effect on the foundation yet. That is really is just a matter of time. Negotiating with the neighbor next-door to remove the tree or at least effectively prune it to curtail future growth is recommended.

Pine tree debris on the roof at 4239.

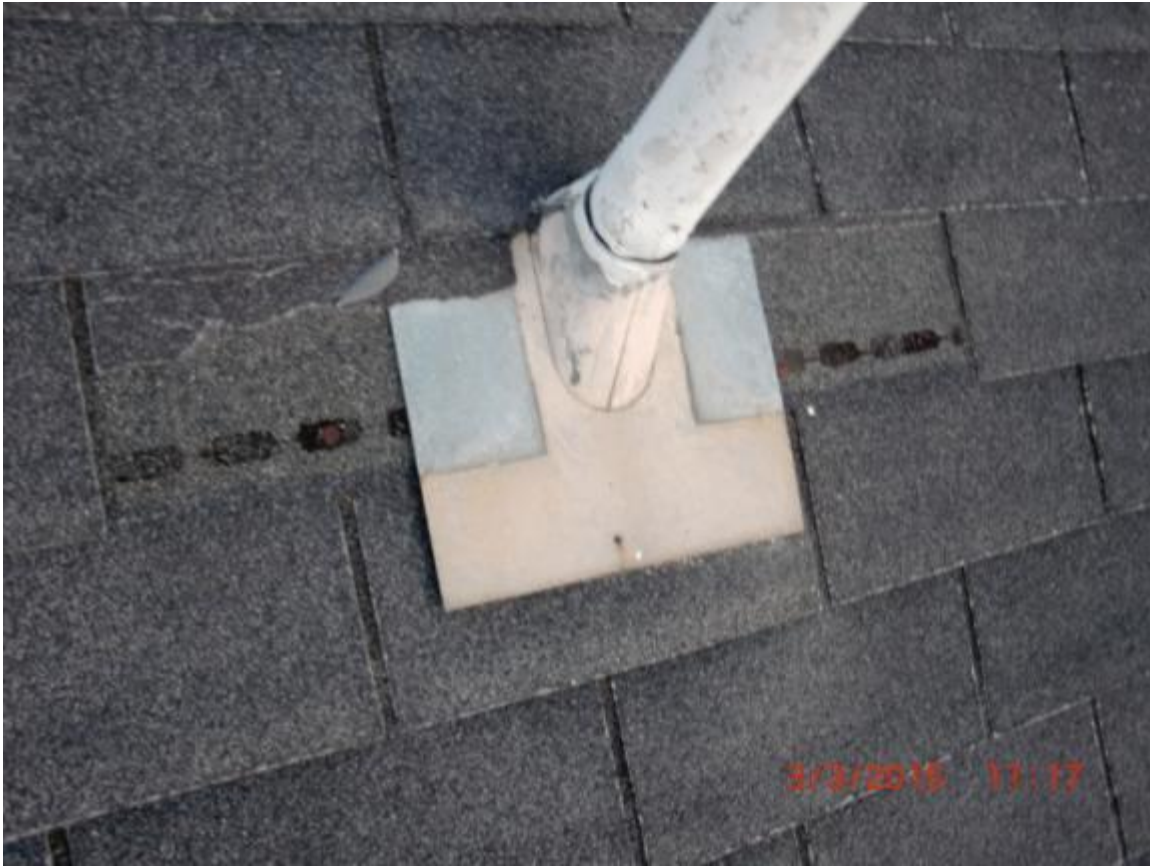
8. A lot of the metal flashings for the fireplace flues at the top of the stack sag and hold water. This is not thought to be a very hard adjustment.
9. Just above that area on the same building there were some missing tabs on the roofing shingle at a plumbing vent. The attic has stains in this area.

Missing shingle tabs at the south side of 4235. There was staining below this area.

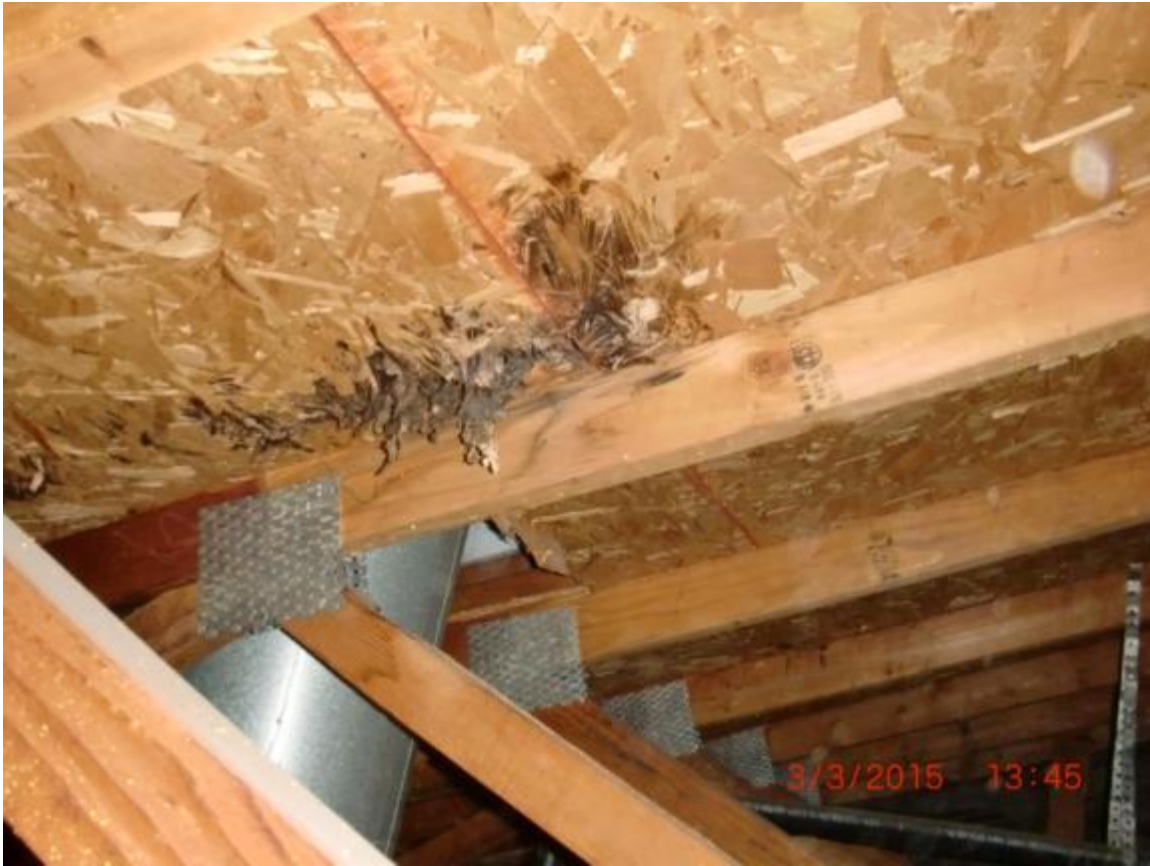
6. Dormers have been patched with mastic. If that is holding anything, it won't for long.
7. There were soft spots in the decking around the chimney extension for 4239#4. Downhill and a little toward the west near there were more soft spots. In the attic water penetration damage was clearly visible. Some decking will have to be replaced.

5. 4239#4 had damage on the roof decking around the fireplace shaft. This looks like it has a current roof leak.
6. Each 2nd floor unit had a skylight. The skylight shafts were framed without cutting the trusses. Some are missing a few pieces of insulation.

Damaged decking from roof leaks near the fireplace chimney at 4239#4.
There are other soft spots in this area.

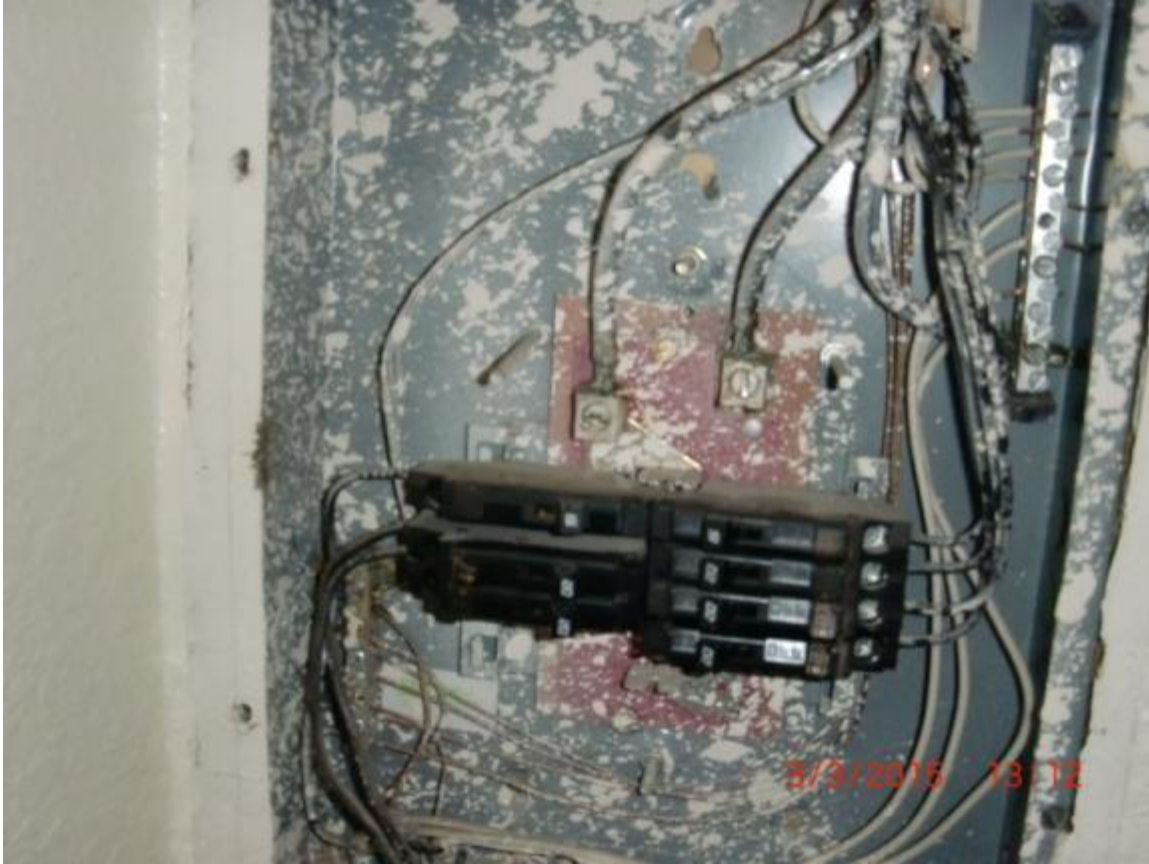
6. The subpanels were Crouse Hinds brand. Each unit had a sub panel in a bedroom behind the door. The cover was removed for inspection in 4239#2 only. No overheated wiring was seen, but there were a few breakers with loose terminal screws, ¼ to ½ turn. Wire sizing was appropriate to the breakers. That subpanel also had fairly heavy drywall splatters that predated the installation of the breakers. At every tenant turnover, with the power off, a qualified electrician should check for damage from the overspray and tighten electrical terminals to specifications.

Drywall splatters on the electrical subpanel at 4239#2. This is not extremely heavy but still could have an effect on the electrical connections. The rest of this complex probably has the same concerns.

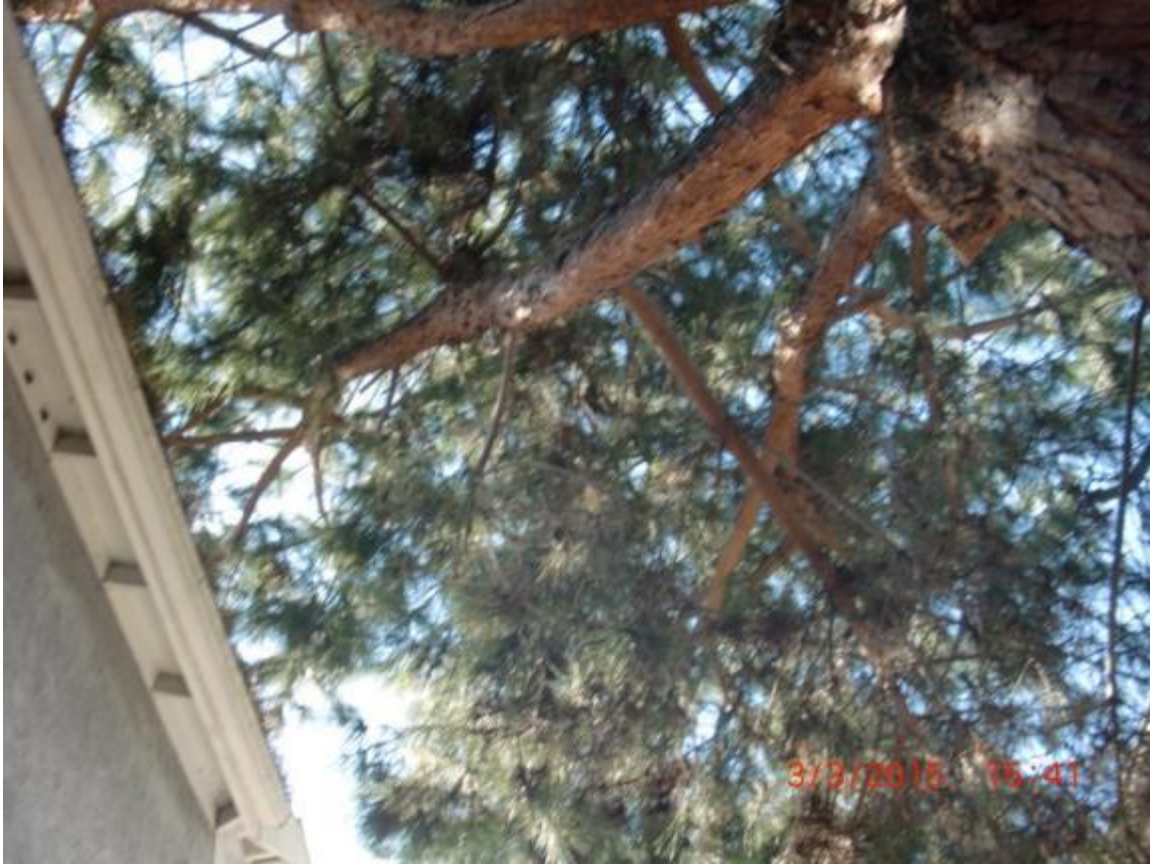
Pine tree at the northwest corner. It leans over onto this property at the property line.

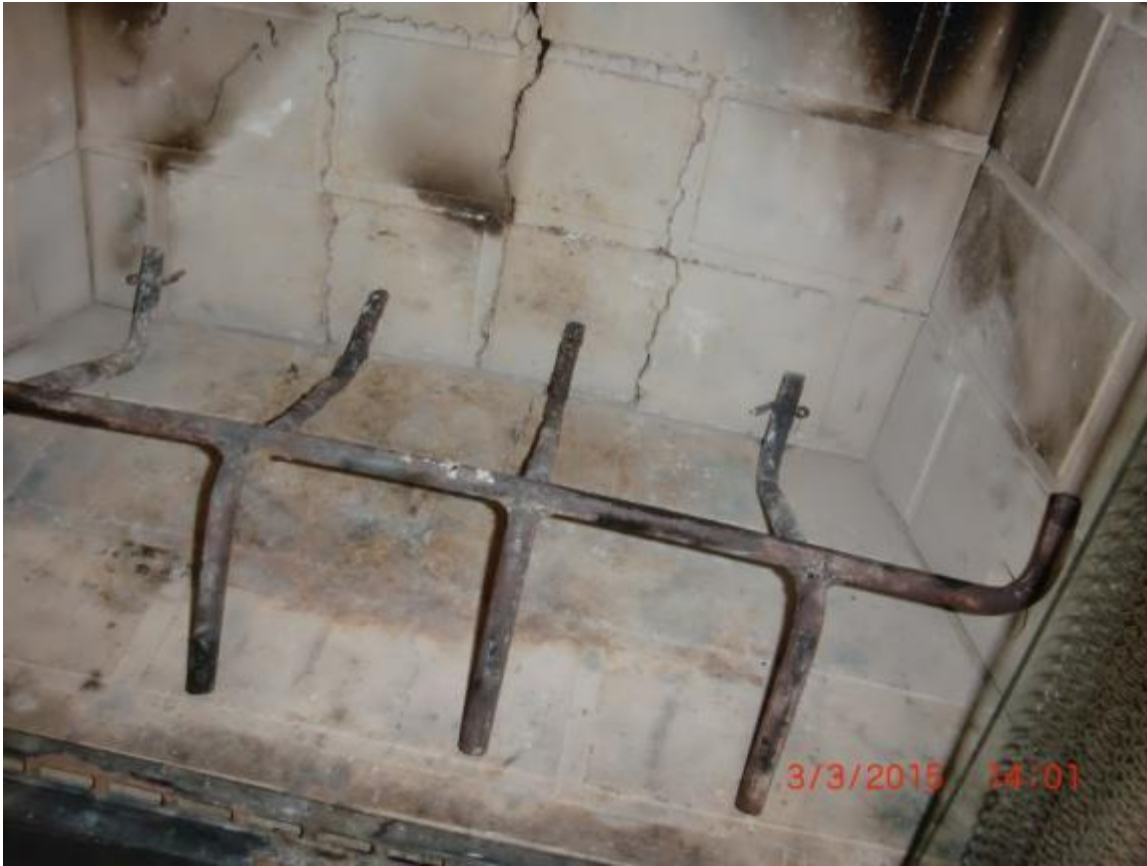
2. There were cracks in several of the back panels and bottom panels. This is usually from overheating. A number of them have been patched with a cementitious material. Usually those patches will crack again, but so far these are holding up reasonably well.

3. 4235#5 and #6 had less cracking than the others. They probably do not need to be repaired or replaced. \$239#7 had more cracking than the others.
4. Professional cleaning by a certified chimney sweep is recommended. Several tenants had wood ashes or wood stored outside the fireplace. The competition burning wood, alternating with manufactured logs such as Pine Mountain or Duraflame is not safe. Cleaning the waxy residue off the walls is recommended.

Cracking at hearth and back refractory panels at 4239#7. This is an example of cracking that is probably too far gone for the patching to hold.

7.	Fireplaces: Patch or re-patch cracked panels. Clean the flues. Note: Replacement panels are reportedly available at about \$600 per fireplace. They are not very difficult to install. This is not included here however. Install one set of doors. A few missing handles.	1500-2000
