Professional Home Inspections

CONFIDENTIAL INSPECTION REPORT

1234 Ocean, San Diego, CA 92105

Structure Style: 20 Unit Apartment Bldg

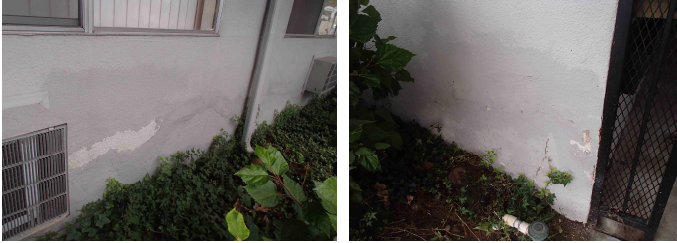
There is typical damage to the stucco, such as cracks, chips, holes, peeling, moisture stains, etc... which is not uncommon, but should be repaired to reduce the risk of further deterioration.

The stucco damage under the porch near the laundry room needs further evaluation and repair. It appears the damage has been caused by the porch and/or gutter leaking.

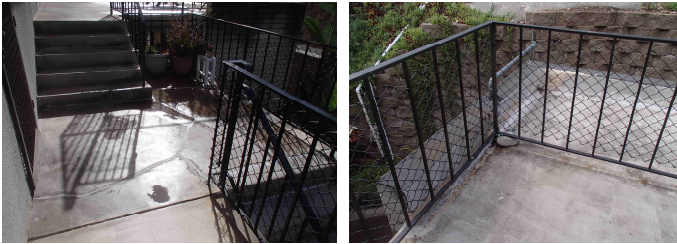
The concrete porch outside the second story apartments is cracked and leaking and needs servicing.

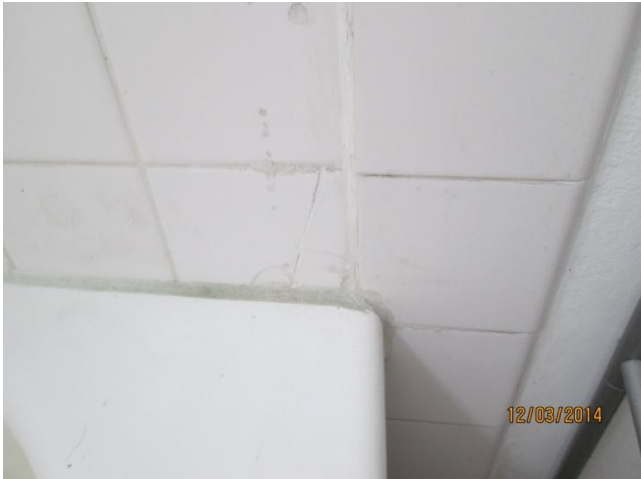
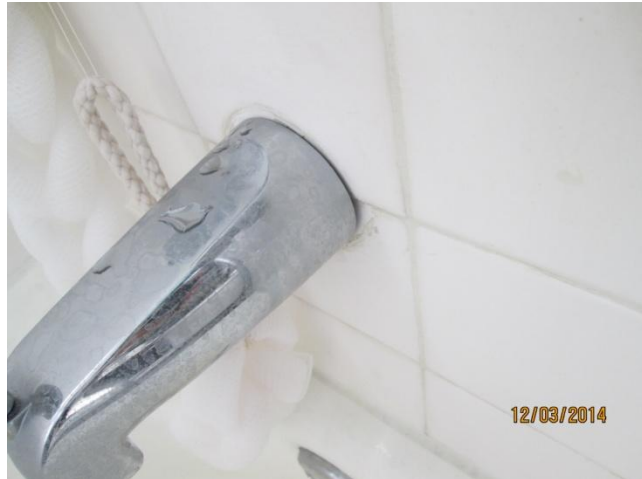
Cracked tiles, lacking caulk seal at fixtures.

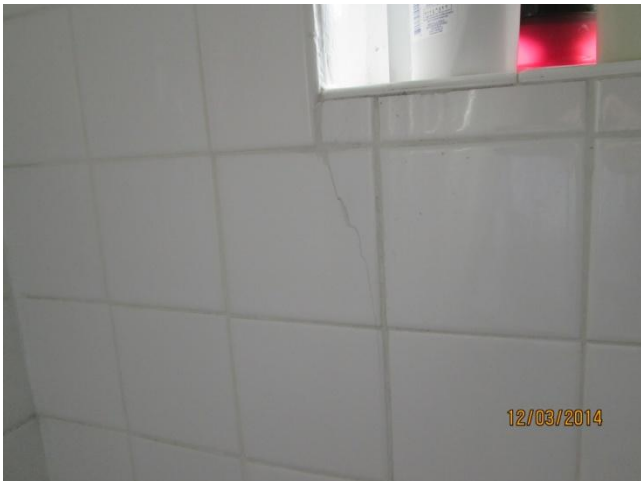
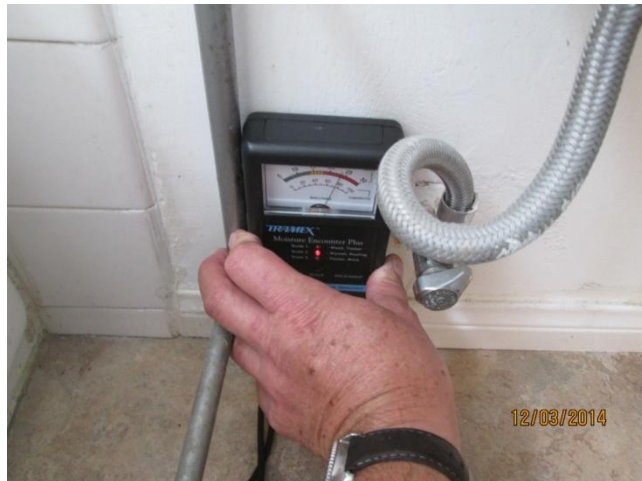
Cracks in tile surround for tub, elevated moisture levels in wall between tub and angle stop.

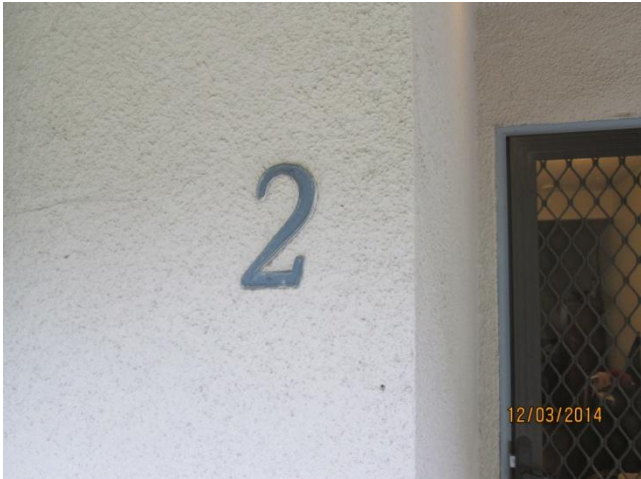
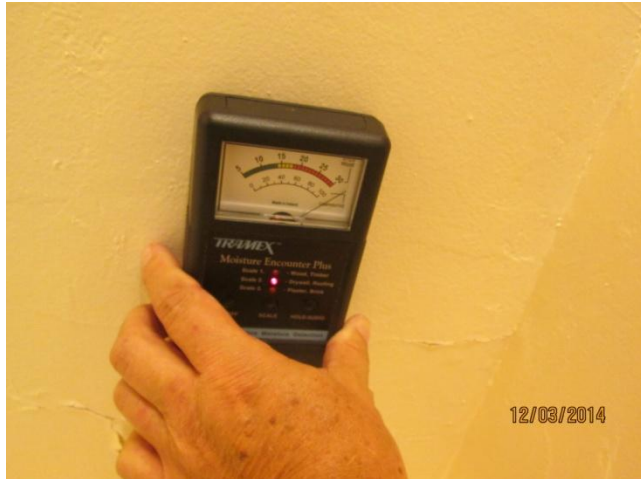
Visible water damage, blistering and wet ceiling in unit 2 bathroom.

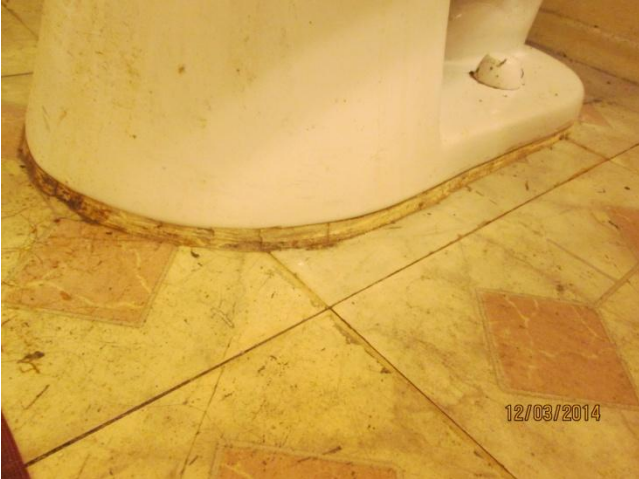
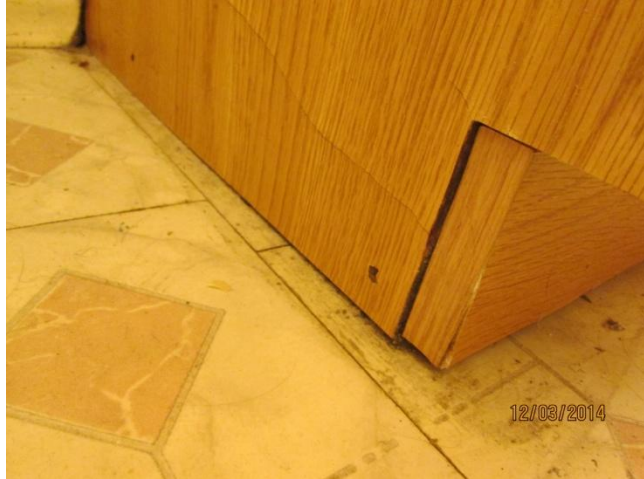
Toilet not seated properly. Bathroom sink cabinet has past water damage, needs replacement.

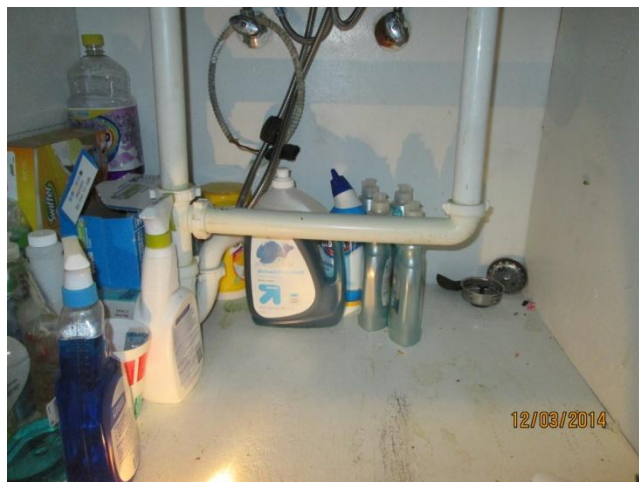
Former leak into sink cabinet now dry, some damage to cabinet side panel shelf has been replaced.

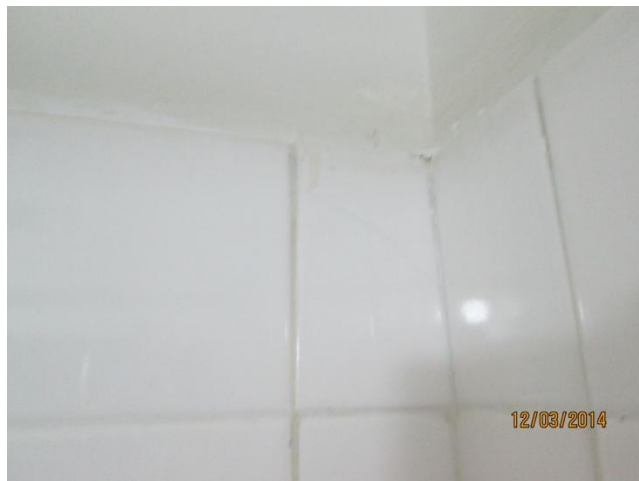
Bathroom shower enclosure tile has cracks; some tile in field is buckling, moisture levels could not be measured as tiles were wet.

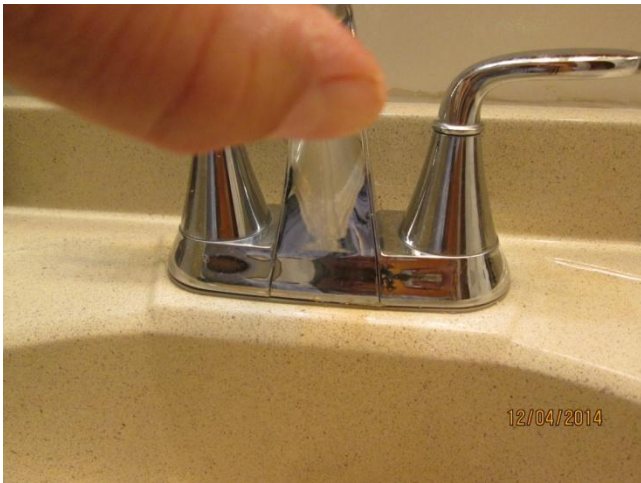
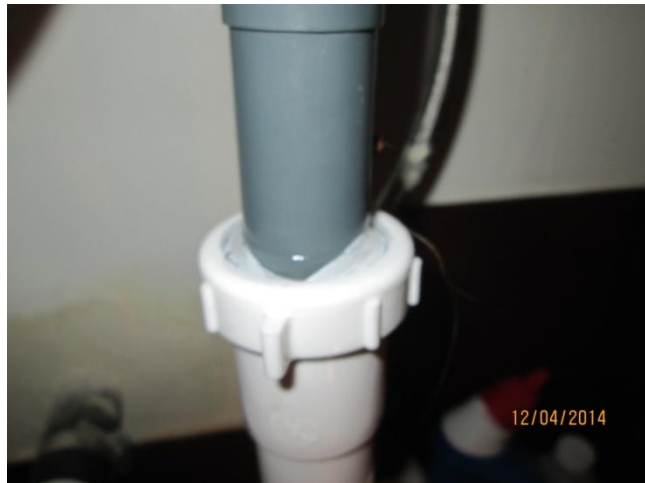
Bathroom

sink fixture not seated properly, drain has water at coupling cap.

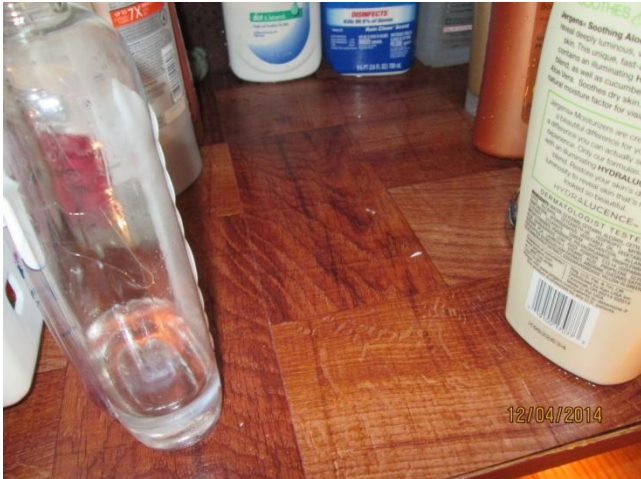
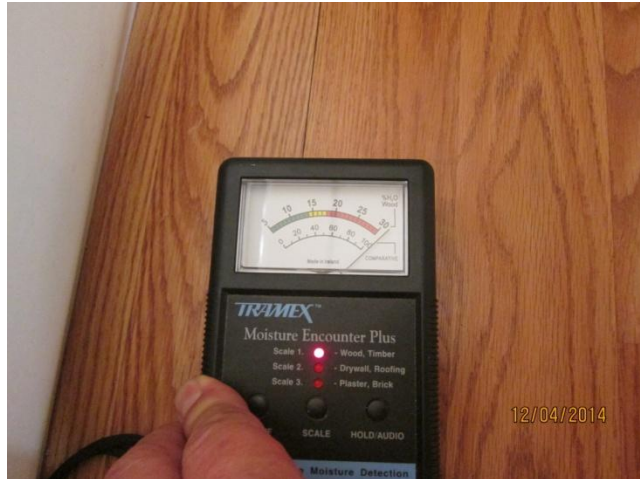
Inside cabinet shelf has standing water. Laminate floor next to tub and around toilet to cabinet is wet.

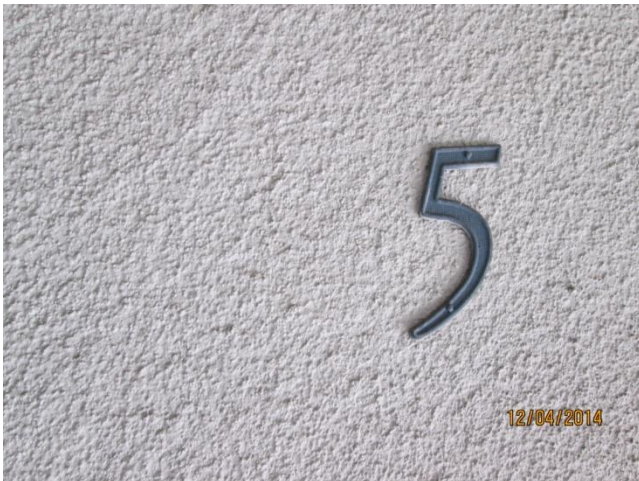
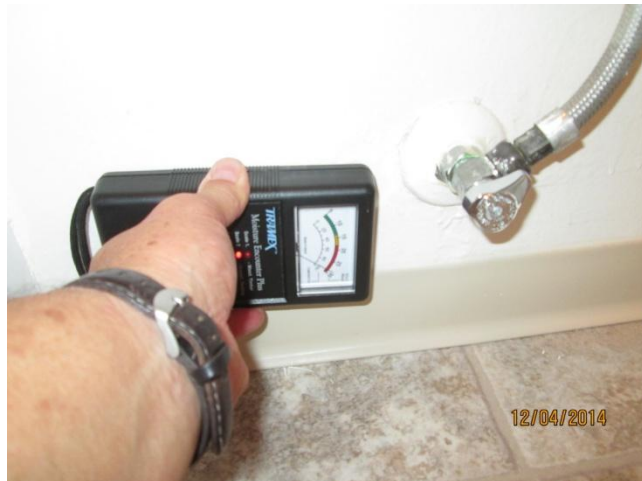
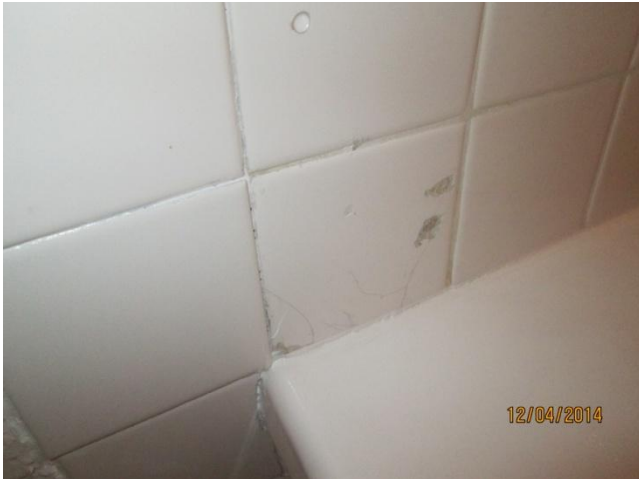
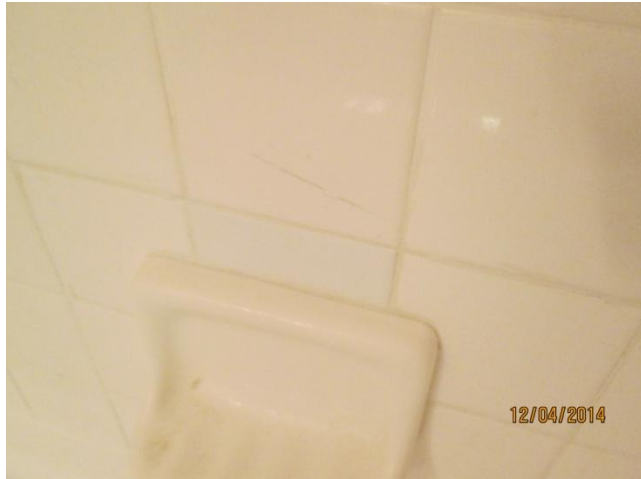
Bathroom wall has elevated moisture levels next to angle stop valve. Tub enclosure tiles have numerous cracks in the field. Fixtures need caulk sealing.

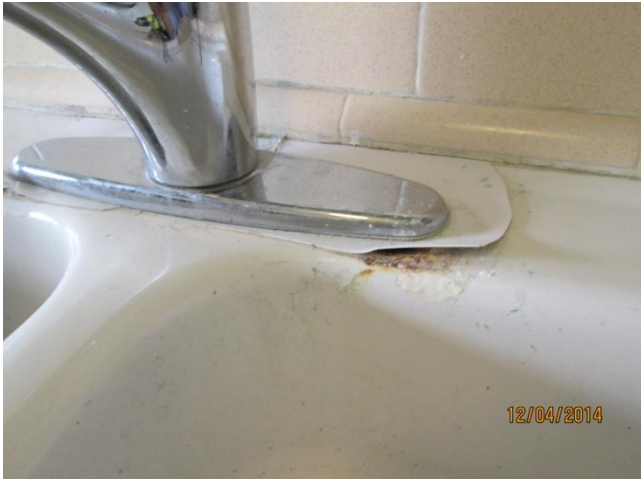
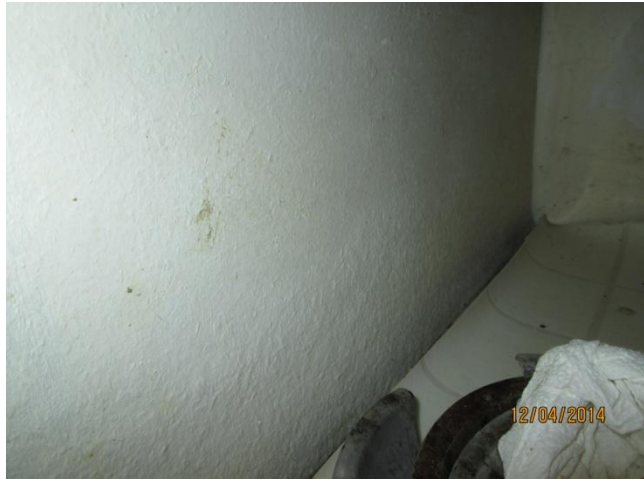
Kitchen sink in poor condition. Sink cabinet has water damage and visible mold.

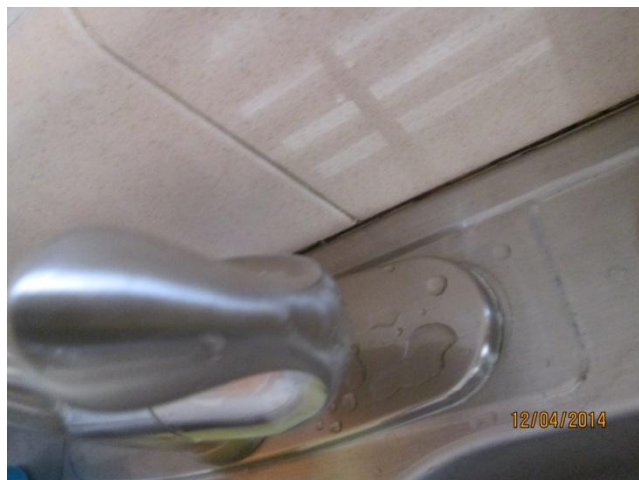
Drywall cut in bathroom to accommodate oversized toilet. Kitchen sink rear seal not sealed properly, no active water leak found. Past water damage noted to kitchen cabinet.

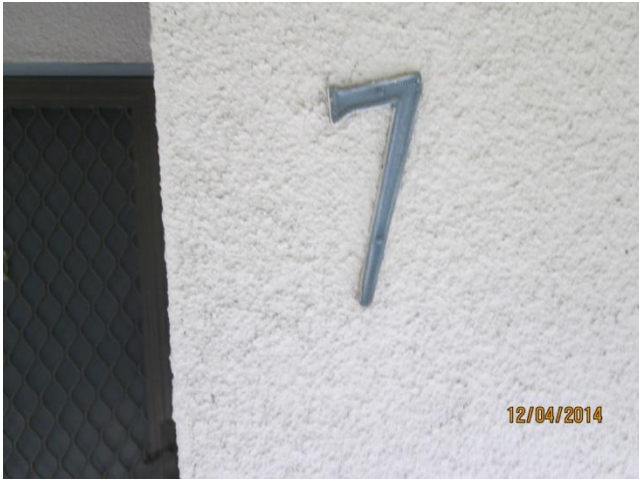
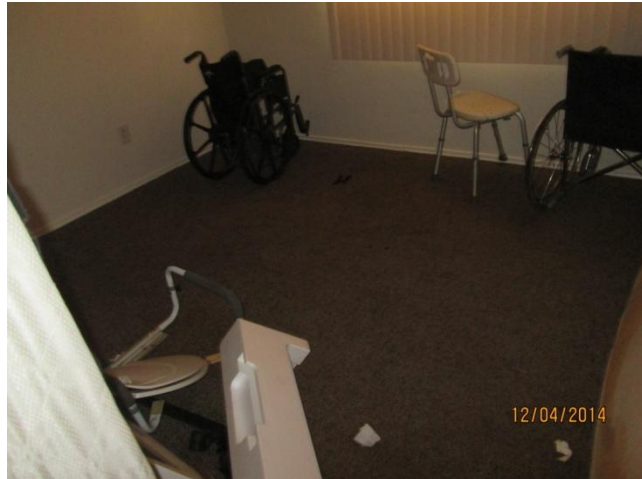
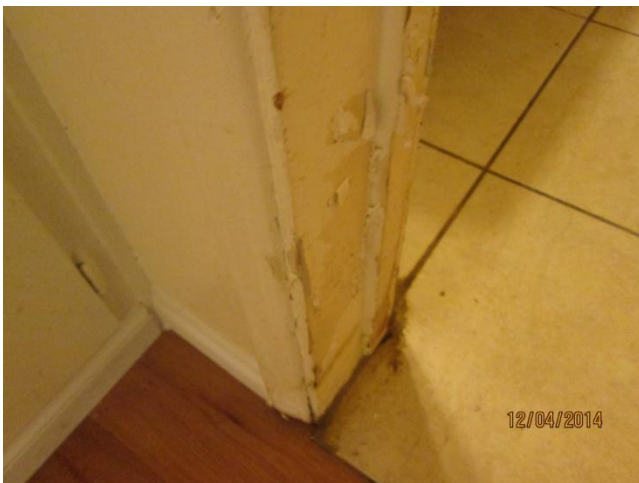
Unit 7 is a handicap unit. There is damage to walls and trim associated with wheel chair use. The bedroom has pet issues, feces noted on carpet surface. Tub fixtures need caulk sealing.

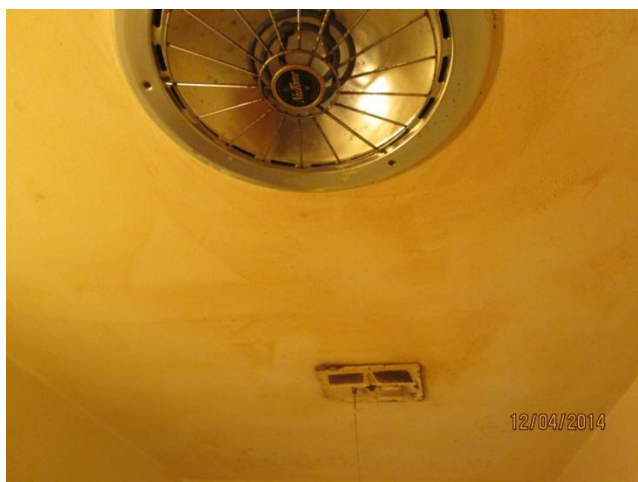
Bathroom ceilings and walls are cigarette smoke stained along with water spots from shower moisture etc. Wall surface does have visible mold.

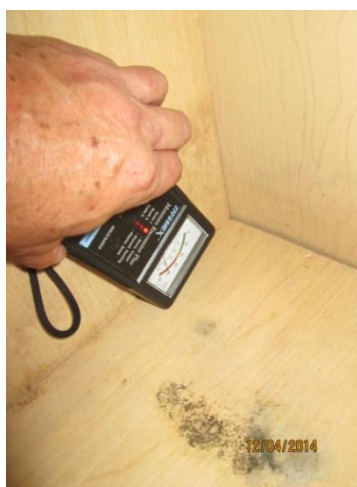
Wall behind toilet and sink cabinet has elevated moisture levels, the cabinet is wet and has visible mold.

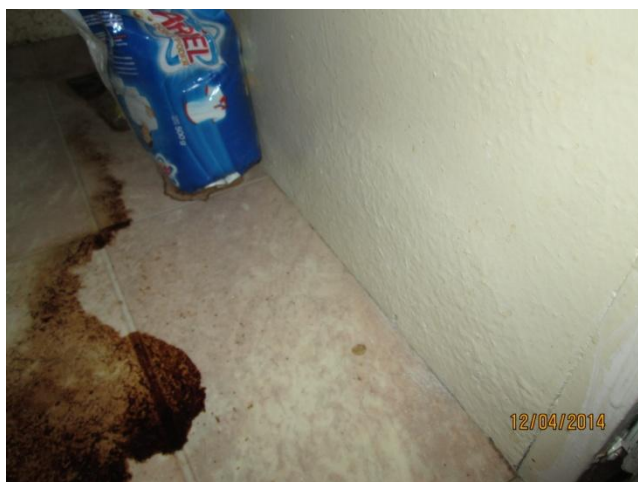
Kitchen cabinets, counter tops are original construction, have past water damage, visible mold and will need replacement.

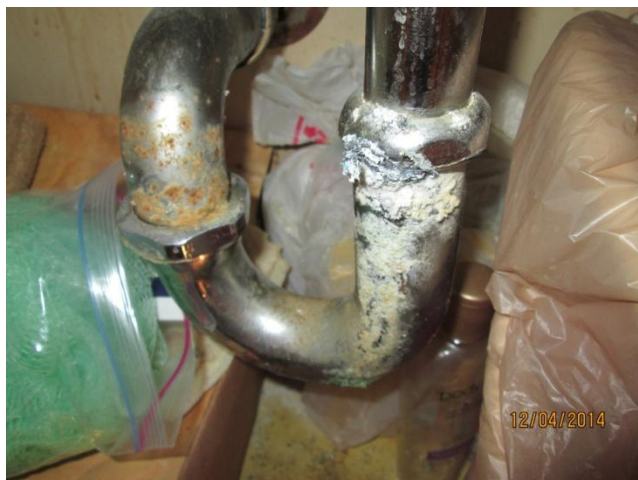
Under sink in bathroom elevated moisture levels and poor drain pipe condition appears to be leaking.

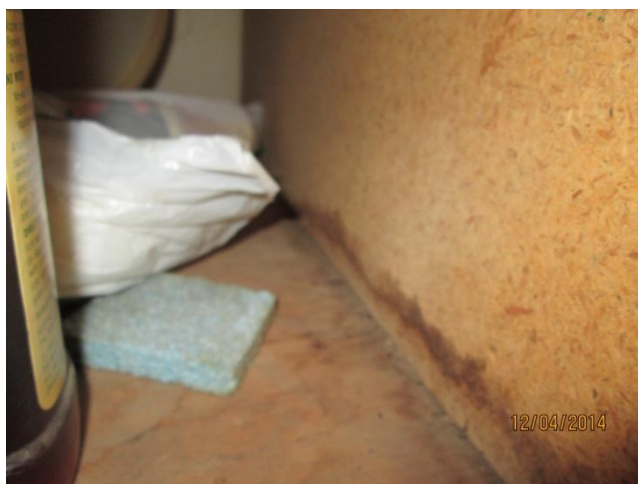
Under kitchen sink revealed dangerous wire situation. Former water damage stains remain in cabinet side panels and bottom shelf. These are dry now.

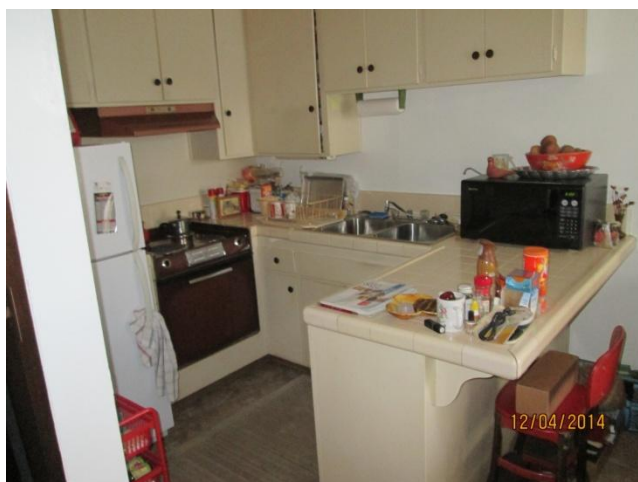
Opposite side of previous photo cabinet panel showing no damage. Kitchen is original construction and will need replacement soon.

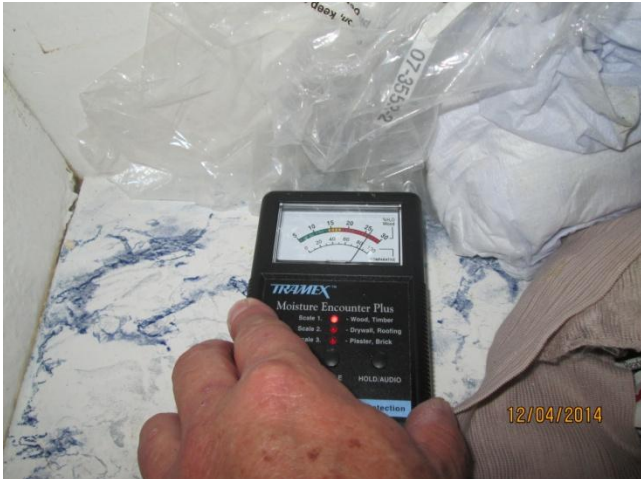
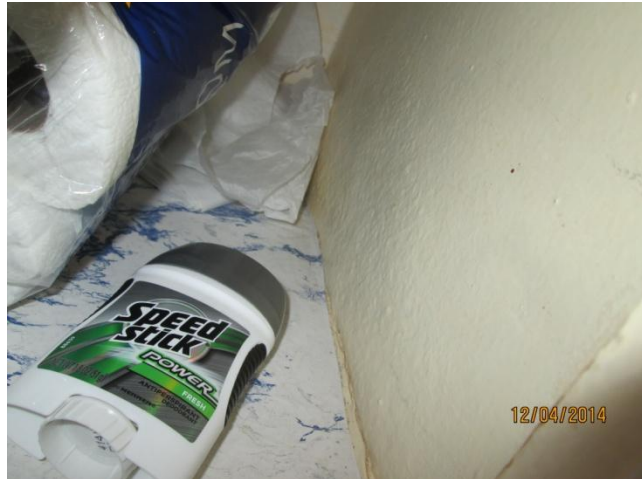
Sink cabinet in bathroom has wet shelf and side panels. Particle board is damaged.

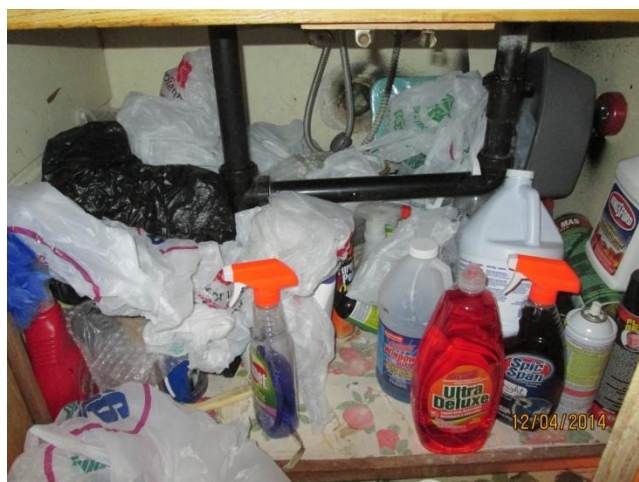
Kitchen sink and cabinet have leak issues and past water damage. Mold noted at cabinet interiors. Cabinets are not original construction but appear to be 25 years plus old, and may need replacement soon.

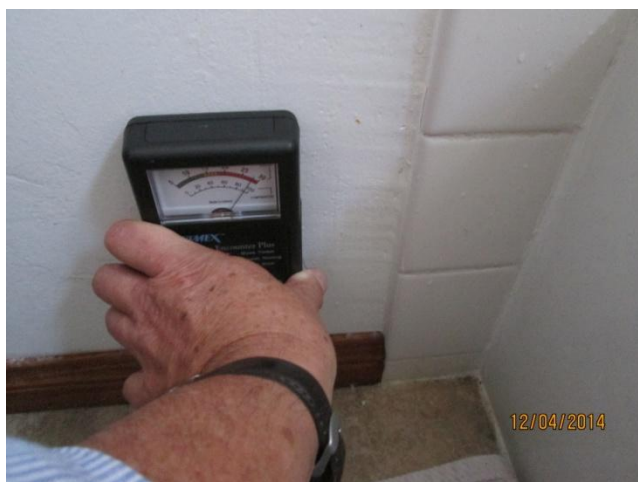
Tub enclosure fixtures need caulk seal. No moisture meter measurements taken on tile surround due to recent shower activity. Wall between toilet and tub tile is showing elevated moisture levels.

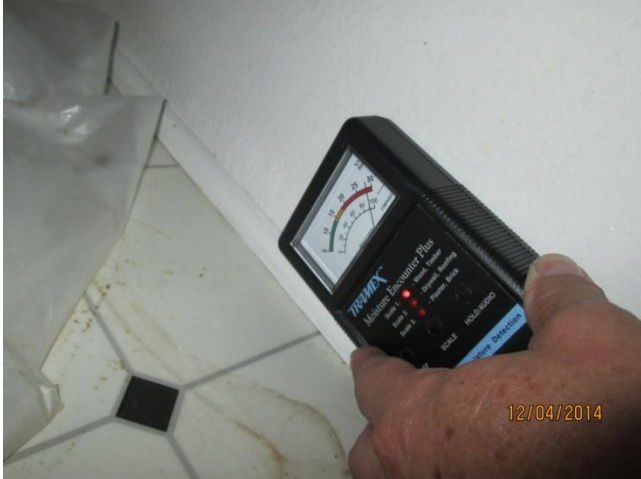
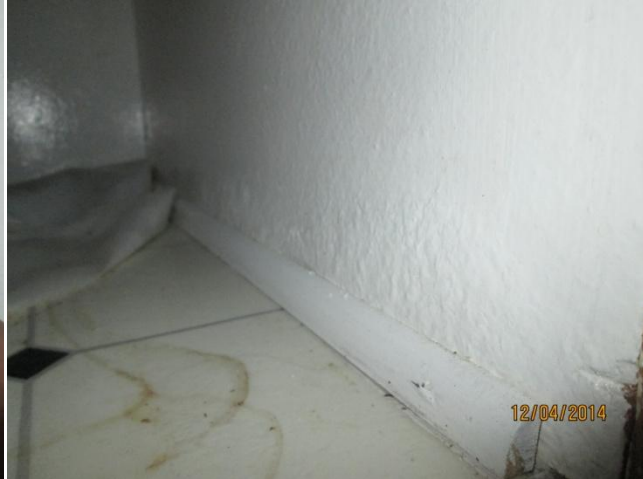
Kitchen sink rear rim seal may be leaking. Standing water found in cabinet below. Side panels to cabinets are wet and the particle board is swollen and damaged on side panels.

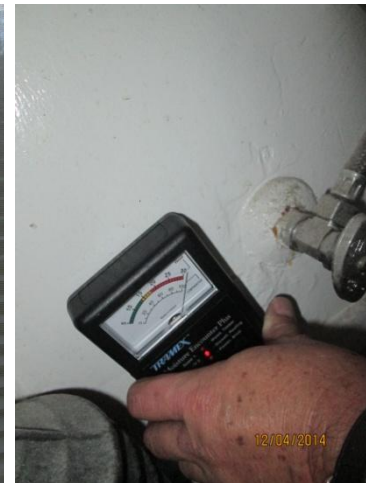
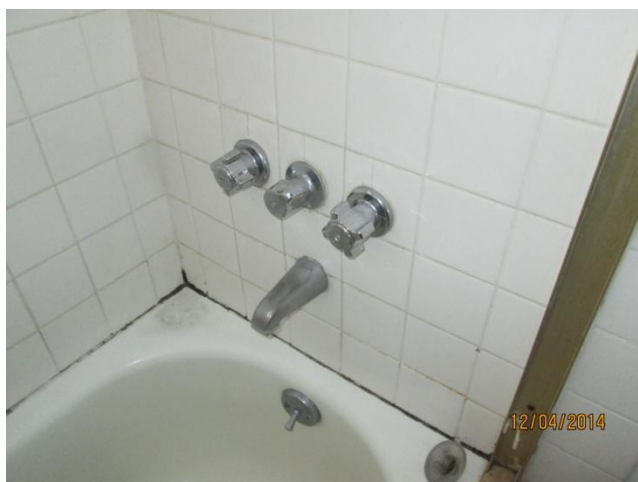
Elevated moisture levels found in wall next to shower wall and between angle stop valve. Shower tile plumbing wall shows elevated moisture levels behind tile. May be the cause of wet wall next to shower and toilet. Bath sink faucet is not sealed properly to cabinet counter. No elevated moisture levels found with the cabinet.

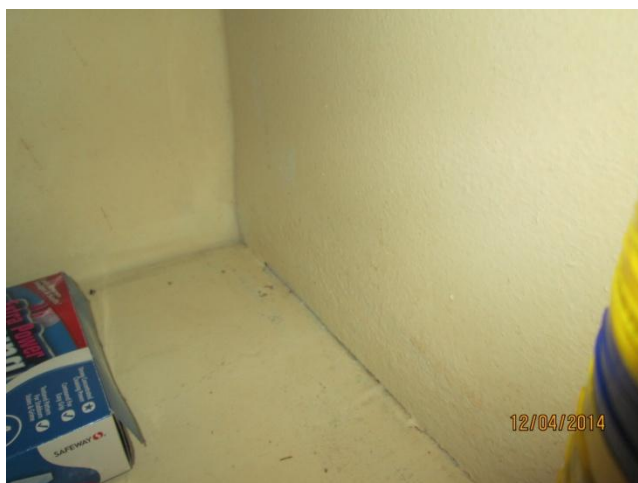
Kitchen water damage and visible mold found in cabinet to right of sink cabinet. Sink cabinet above right shows it has been painted and the particle board side panel shown is swollen from previous water damage event.

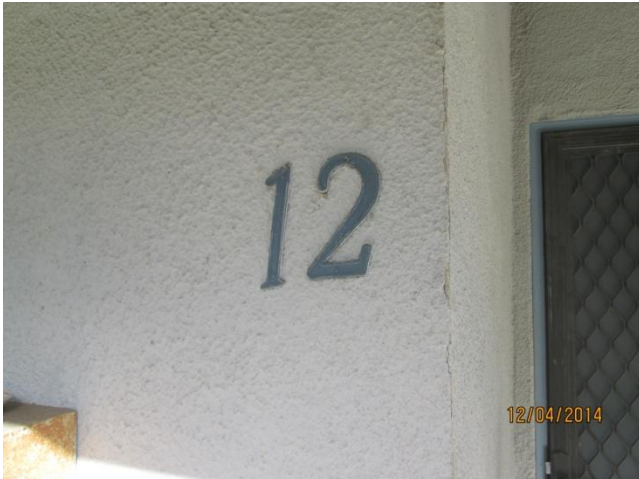
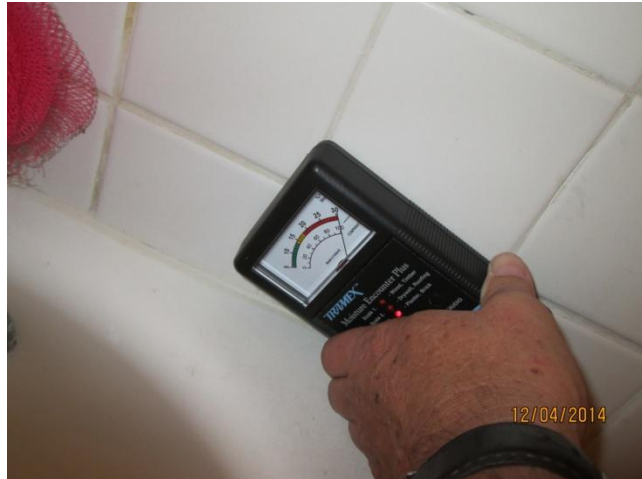
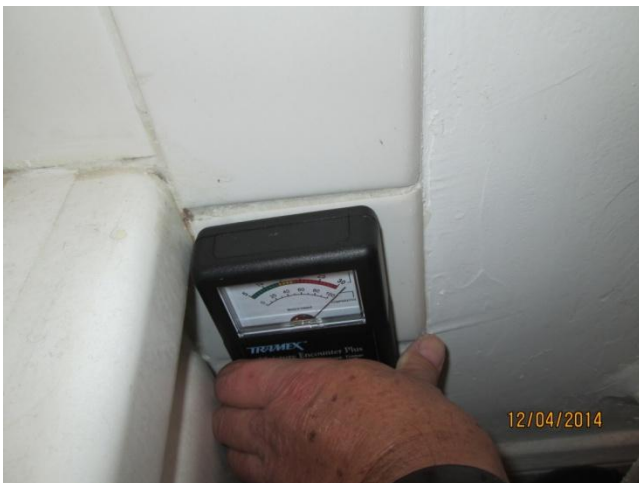
Tub enclosure plumbing wall behind tile is showing elevated moisture levels as well as tile to side of tub and drywall next to tub towards and behind toilet. Toilet runs continuously.

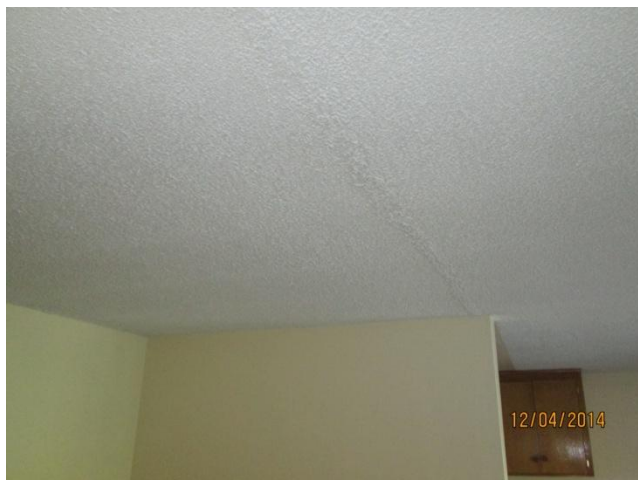
Ceiling of living room has a repaired but visible crack that runs the width of the room.

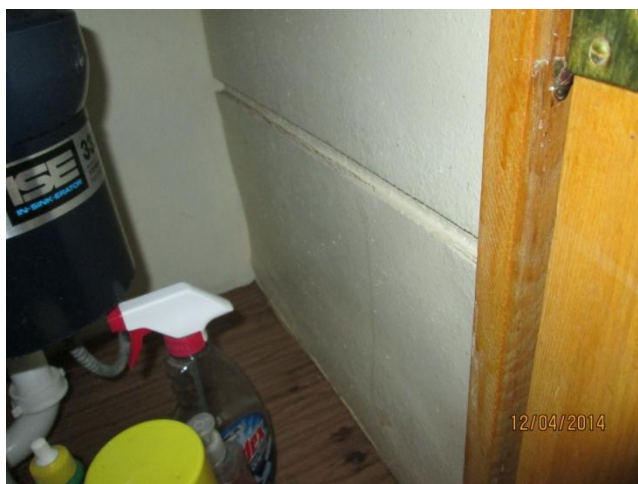
Kitchen ceiling has repaired crack in the same direction as living room crack. The sink cabinet has past water damage and the damaged cabinet side wall panel has been painted.

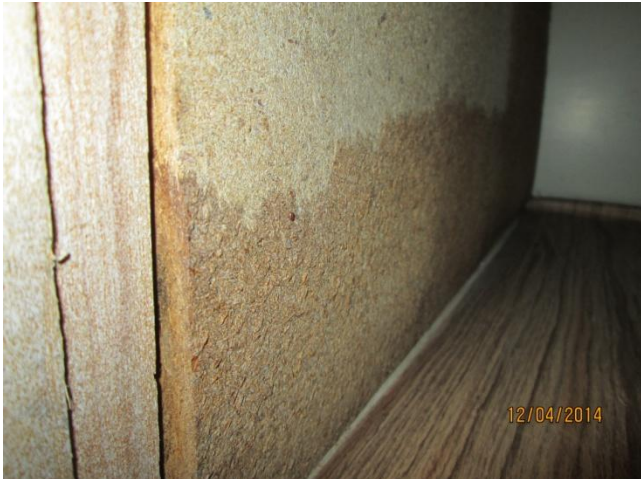
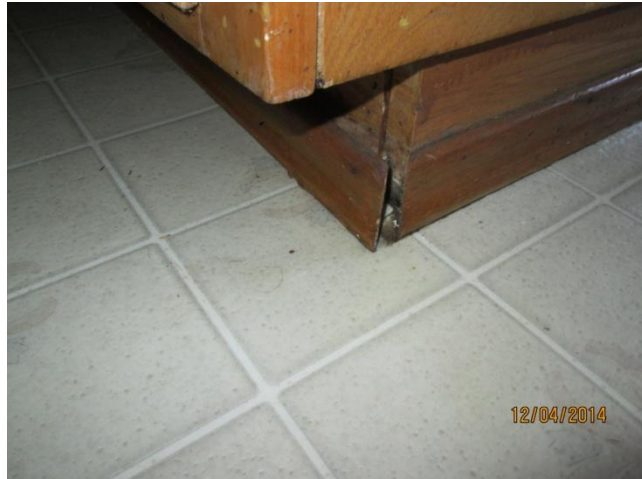
Backside of panel showing unpainted water damage in side cabinet in kitchen. The warped water damaged base molding on kitchen cabinet is shown above right.

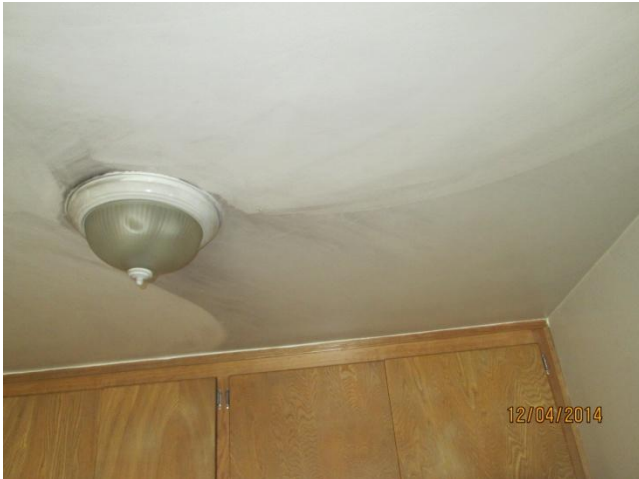
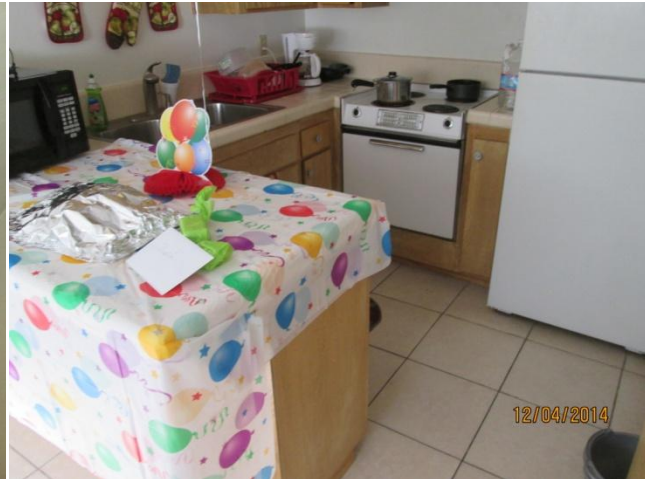
Additional view of other area of smoke damage in kitchen. No other issues noted in this unit.

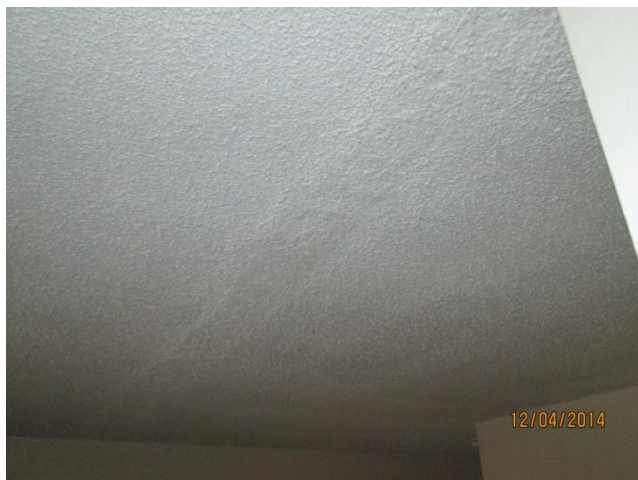
Elevated moisture levels found to right of tub on wall behind toilet. Living room ceiling has a repaired crack running the width of the room.

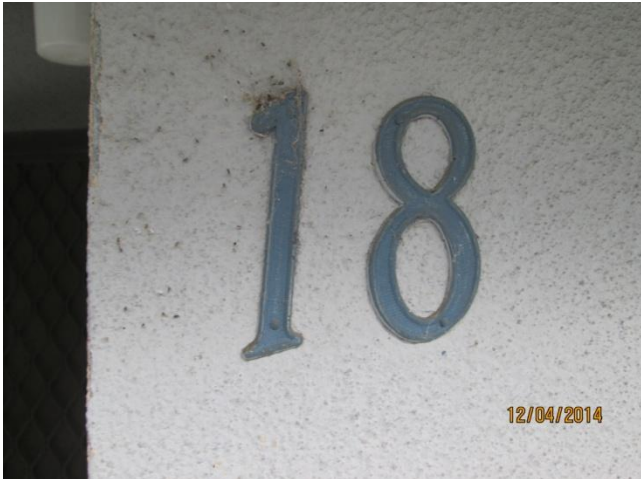
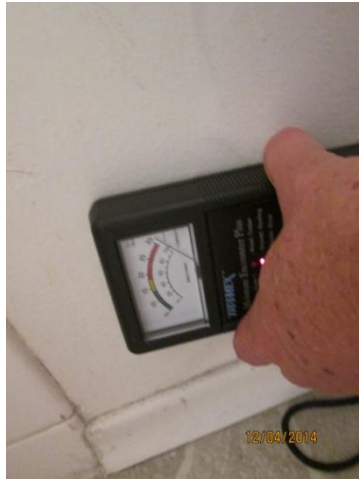
Elevated moisture levels going up 2' from floor to side of tub enclosure in bathroom. Dining room ceiling has repaired crack running the width of the ceiling.

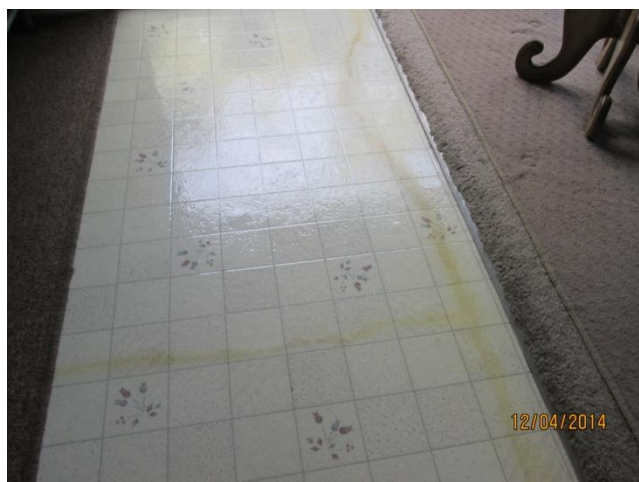
Dining room and kitchen floor has unusual discoloration coming up from below affecting the flooring material. Suspect crack in subfloor under this flooring causing the damage and discoloration.

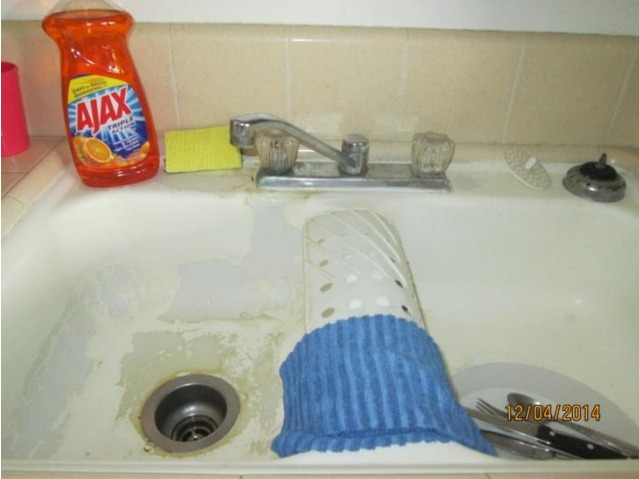
Kitchen sink in poor condition needs replacement.

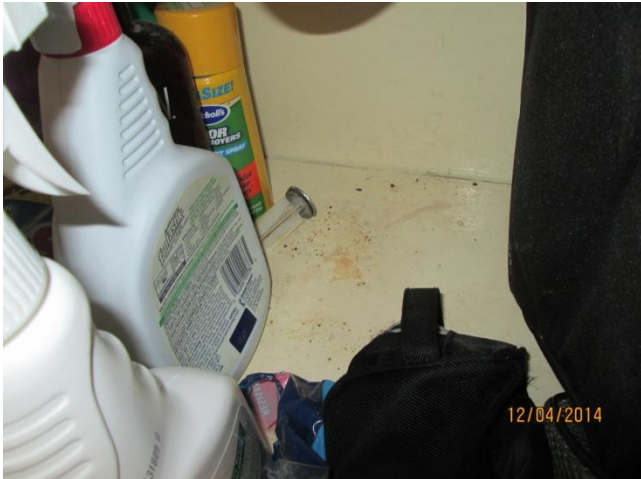
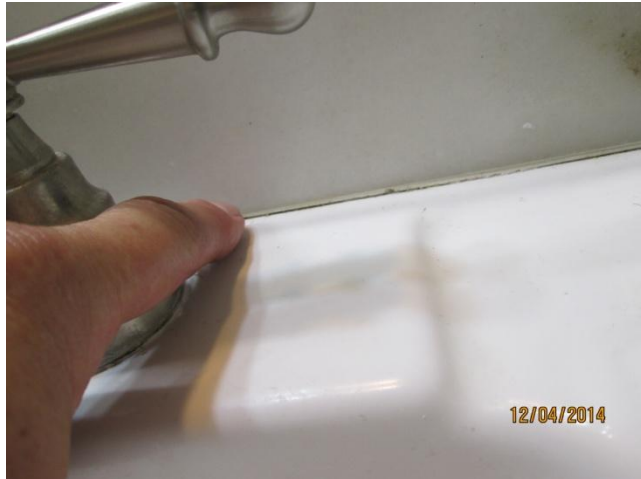
Bathroom sink cabinet shelf has elevated moisture levels due to lack of good caulk seal at rear of sink.

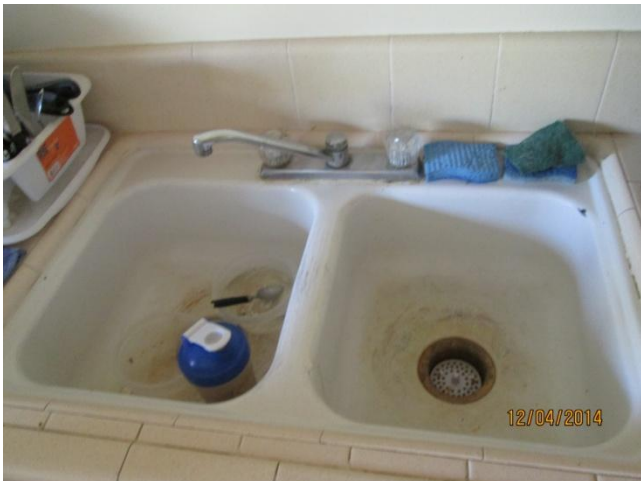
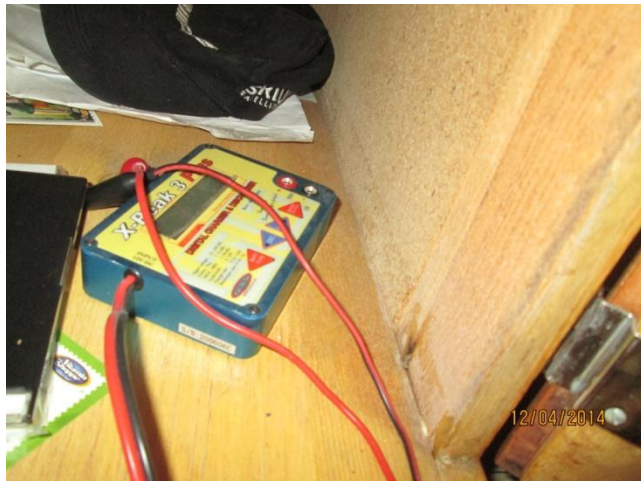
Kitchen sink is in poor condition, inside sink cabinet shows stains from former leak on shelf and side panel.

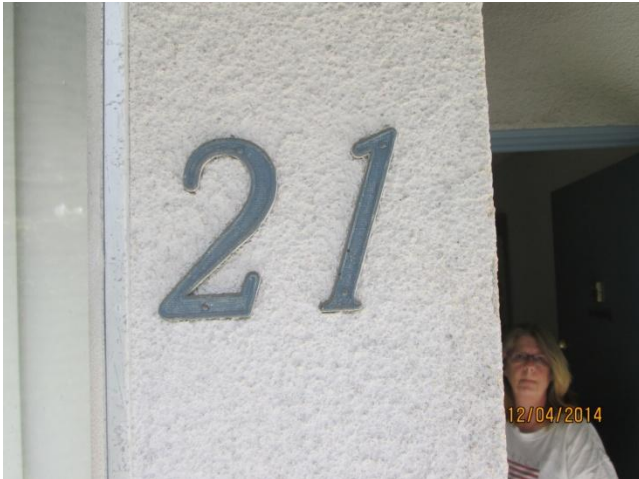
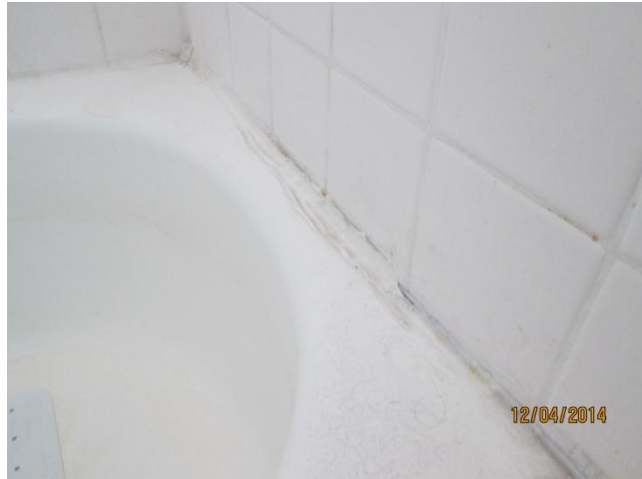
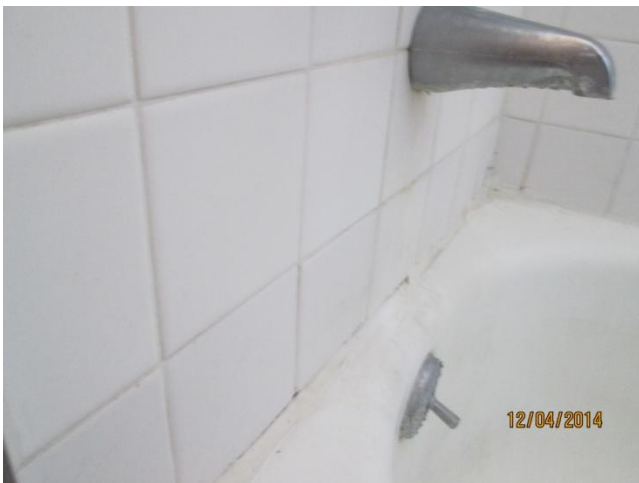
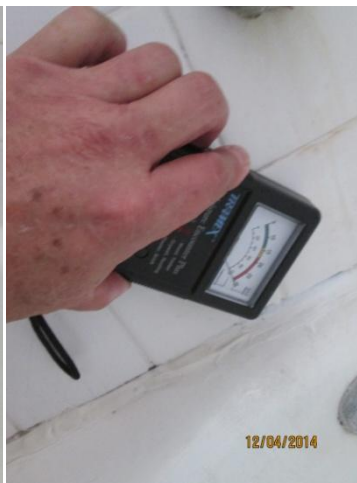
Bathroom tub enclosure tile walls are bowed and have high moisture levels behind tile. Numerous areas of caulk sealer applied heavily.

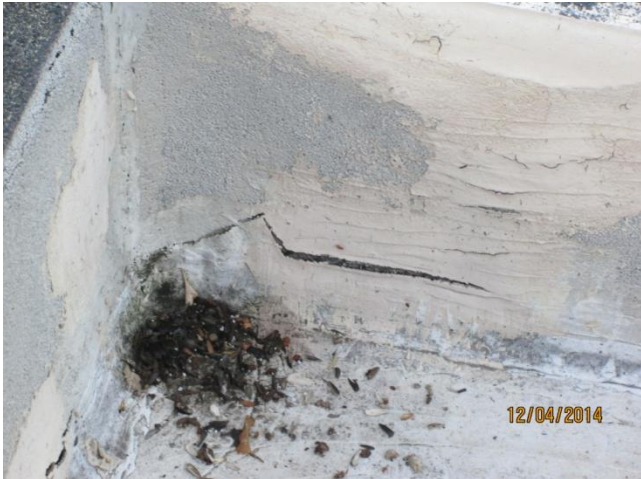
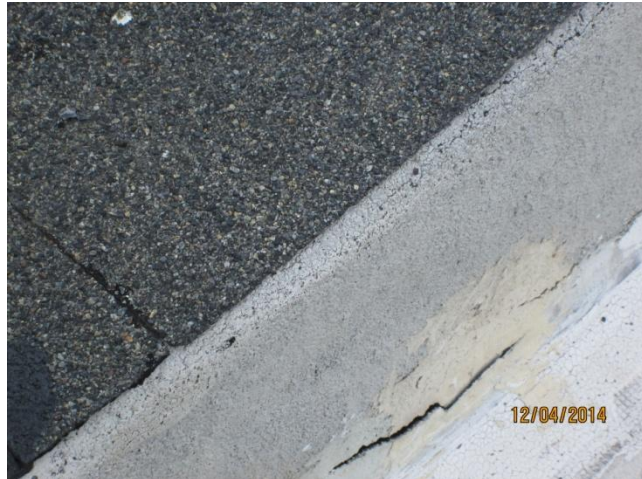
Additional areas of compromised water proofing above laundry room and water heater room.

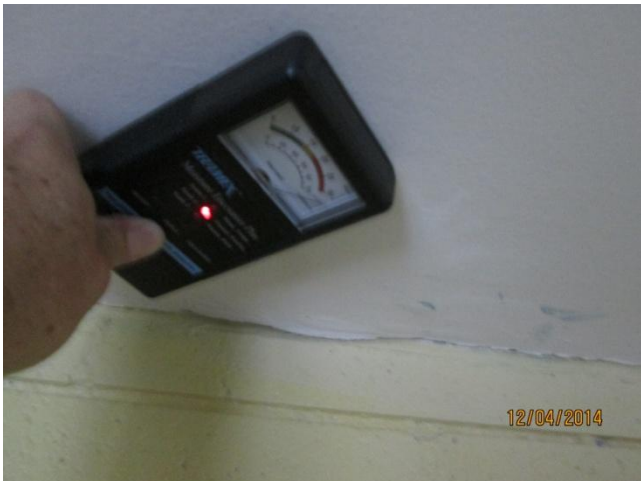
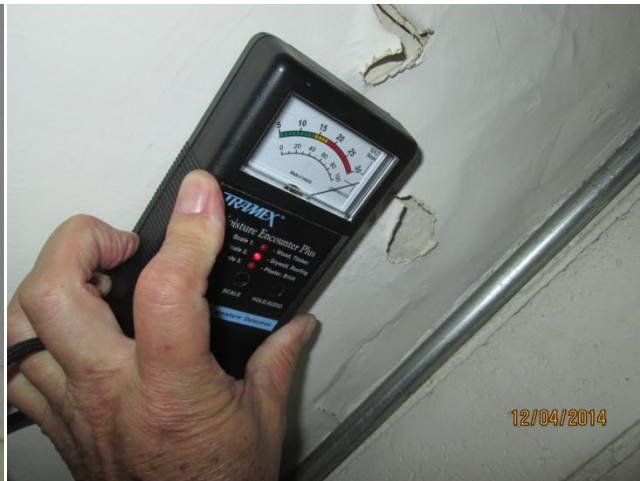
Laundry room ceiling showing water damage and blistering and wet readings on meter.

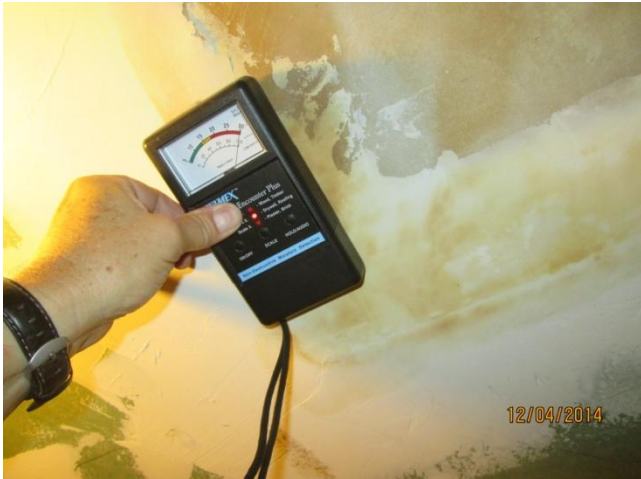
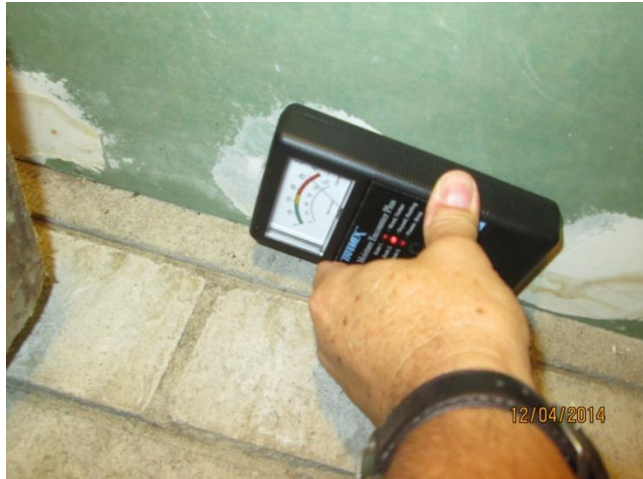
Water heater room ceiling is wet as shown by the meter readings. Entire ceiling is water stained.

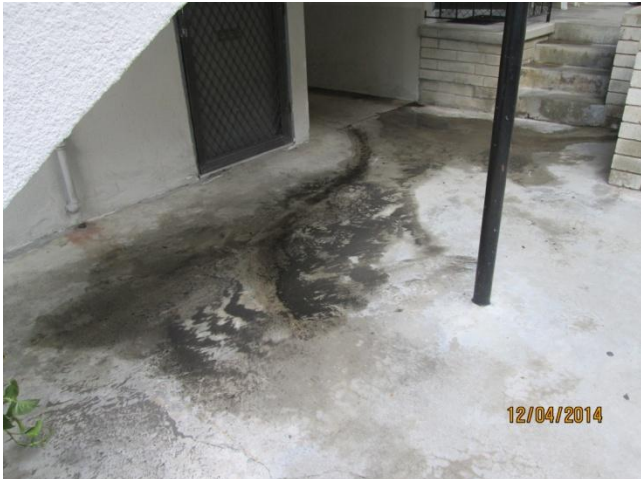
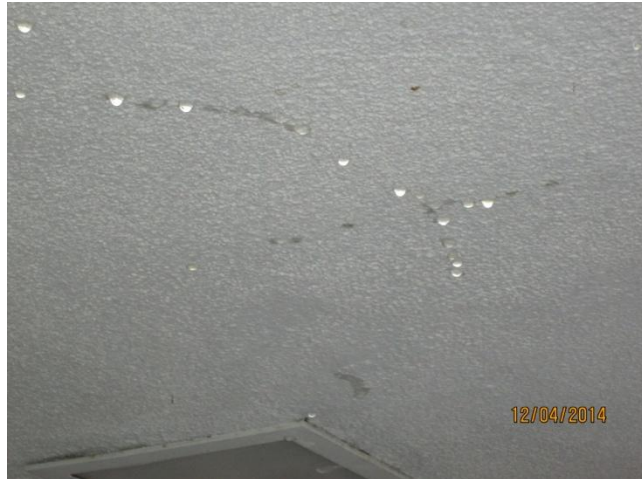
Results of water entering cracks on second story balcony walkway and dripping through the soffit area, stucco to the sidewalk in the main traffic area below.
