Professional Home Inspections

CONFIDENTIAL INSPECTION REPORT

1234 Ocean, San Diego, CA 92105

Structure Style: 20 Unit Apartment Bldg

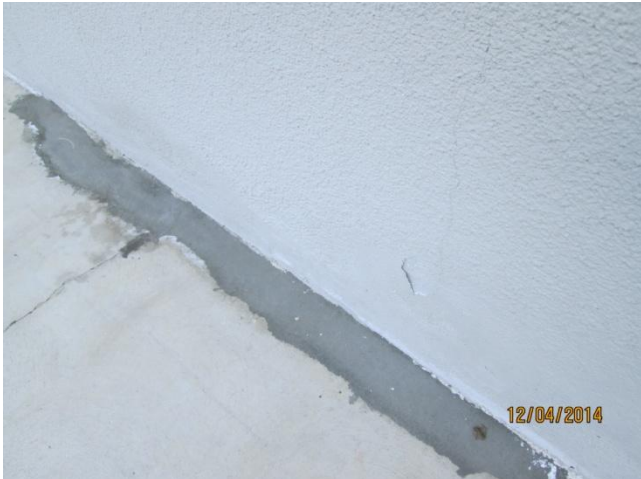
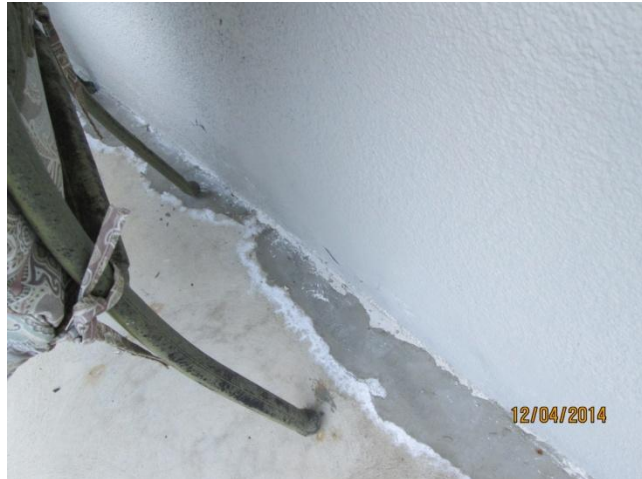
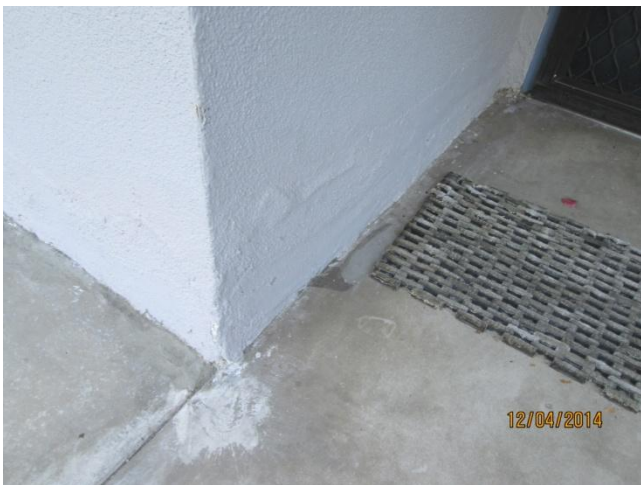
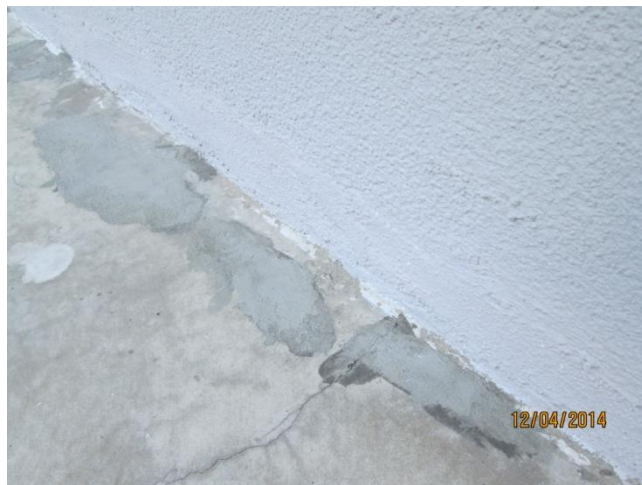
Wall has been painted from below window down. The stucco has been patched along the bottom two feet due to blistering and spall from moisture.

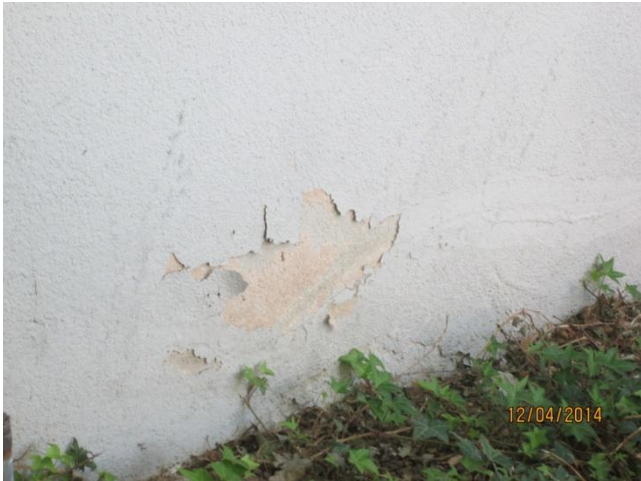
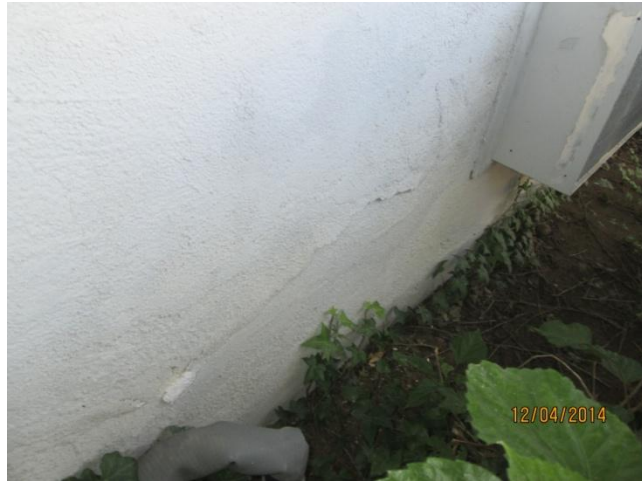
Above photos show stucco damage, spall and blistering from excess ground moisture wicking into the stucco material due to lack of weep screed installed at the stucco wall.

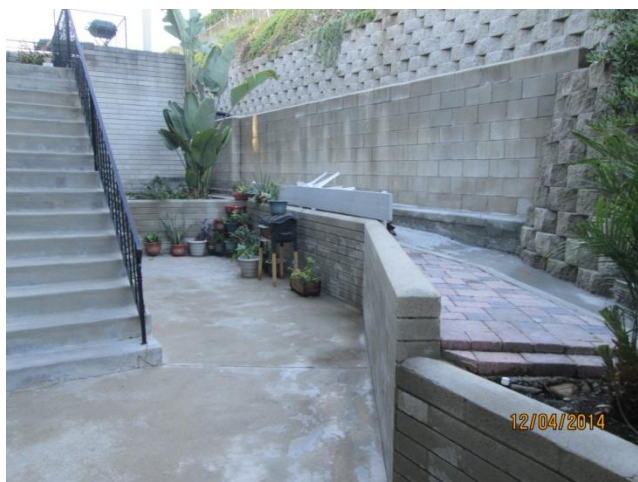
Above photos show the complex rear elevation retainer wall system and drainage that appear to have been subject to designed by engineer and implemented to stabilize hillside and provide water release from the slope. Consider retaining the appropriate engineer to evaluate wall system and hillside stability as well as effects on foundation and the structure in general.
